Sandpiper Towers Condominium

Condition Survey Report Exterior Building and Balconies

Prepared By
James E. Emory, P.E.
Florida Registered Professional Engineer
Special Inspector #60965

November 11, 2019

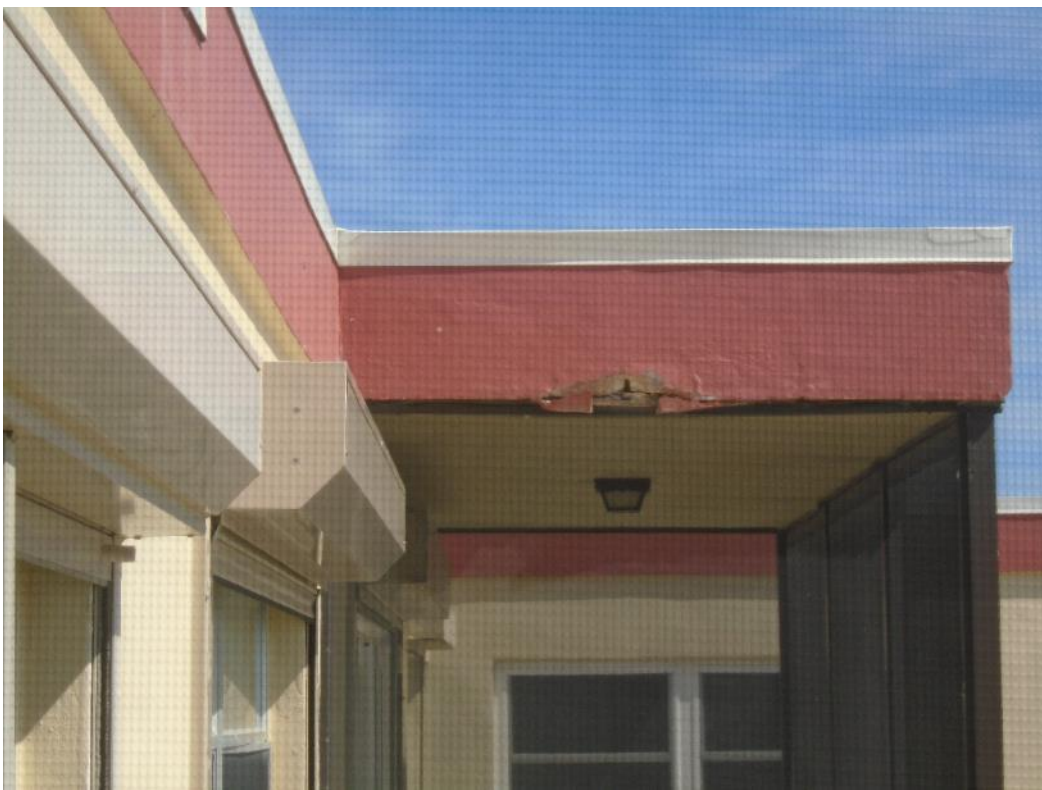
Example view slab edge Concrete spalling due to reinforcing steel corrosion

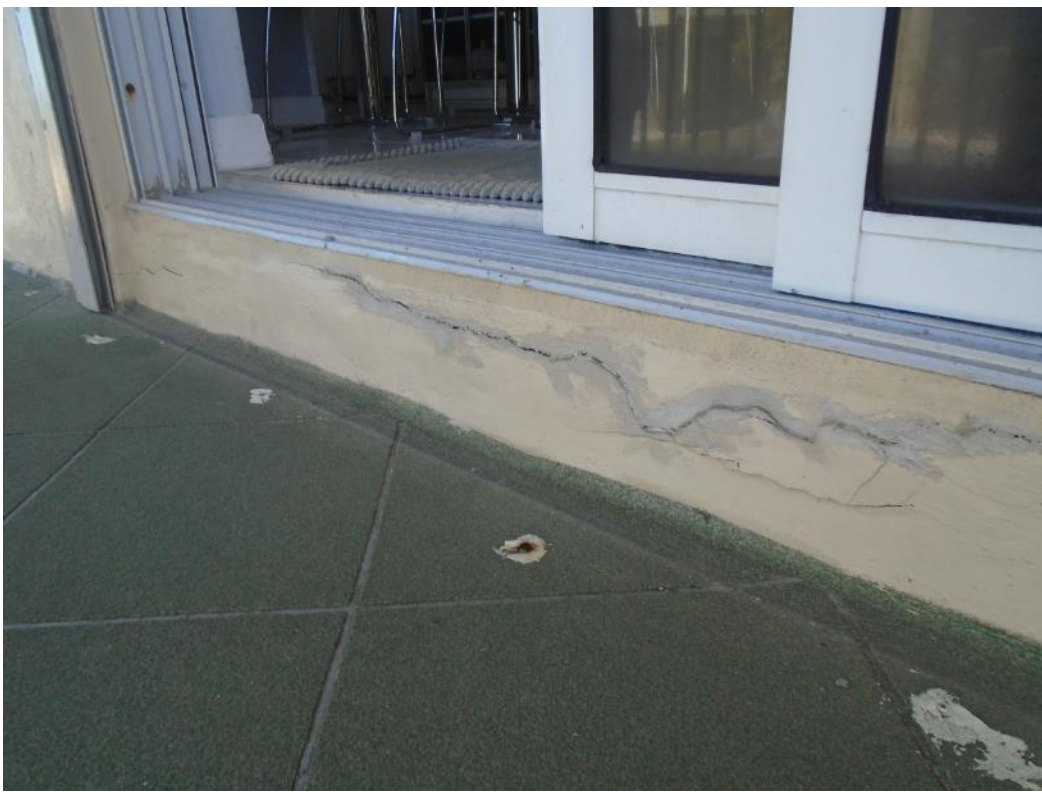
Example view Window Sill Concrete spalling due to reinforcing steel corrosion

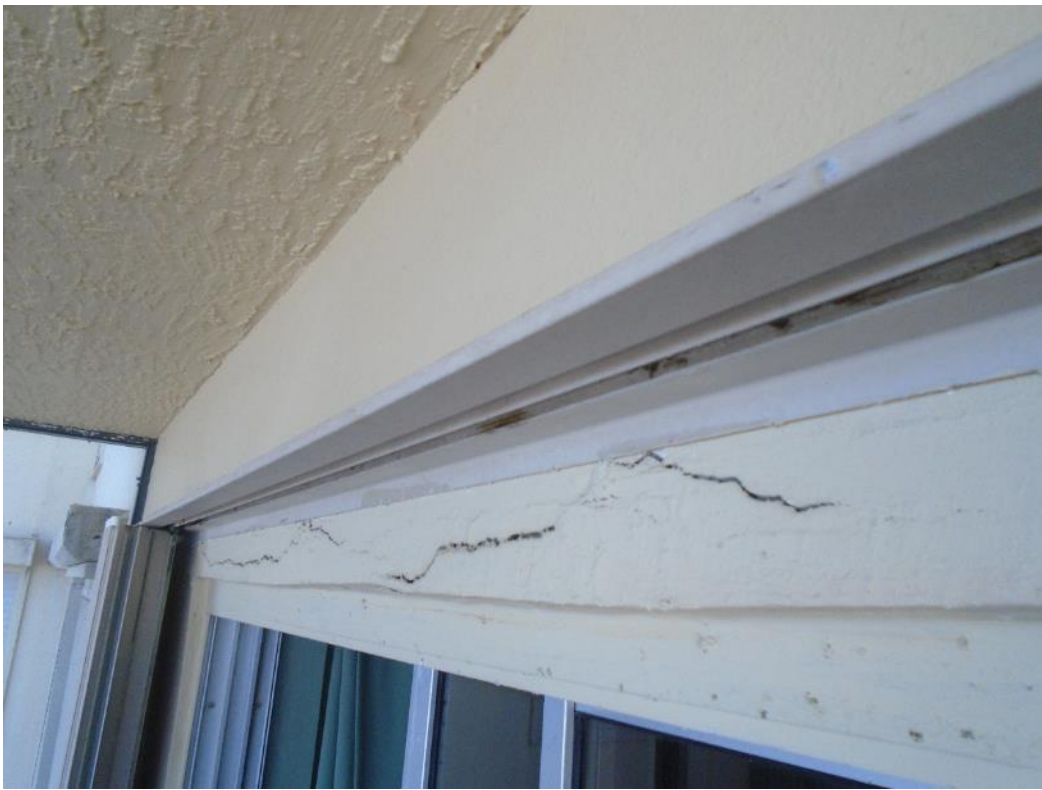
Example view Exterior Wall Concrete spalling due to reinforcing steel corrosion

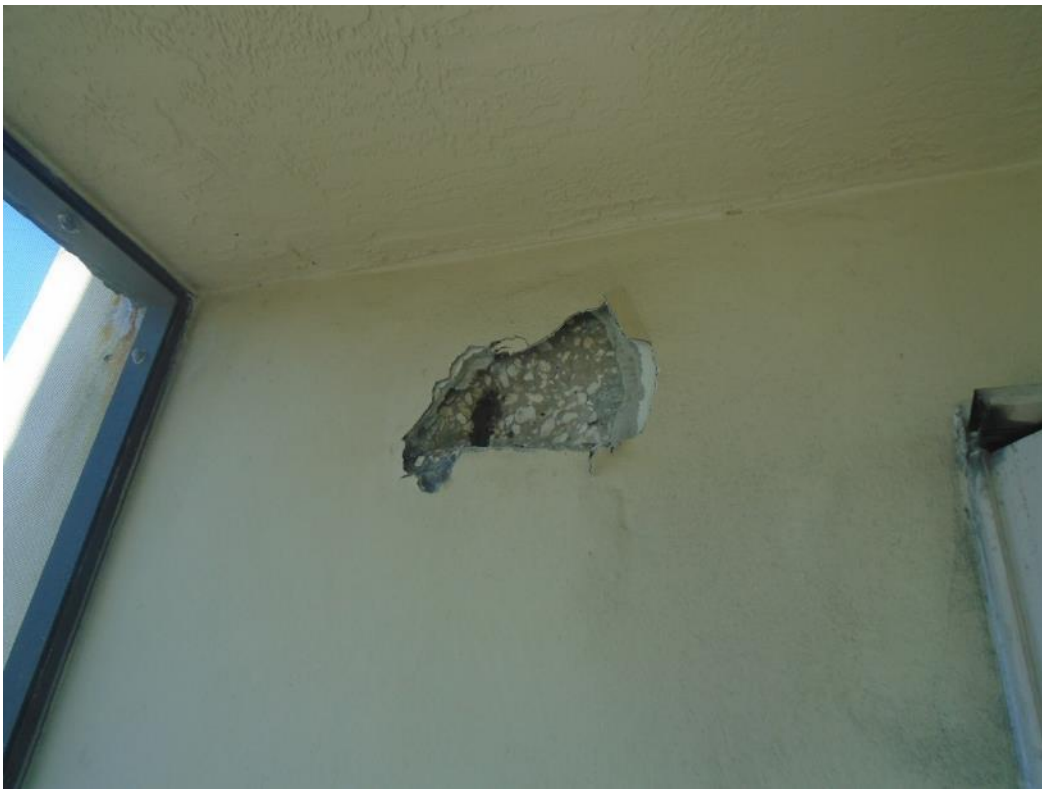
Example view Stairs Concrete spalling due to reinforcing steel corrosion

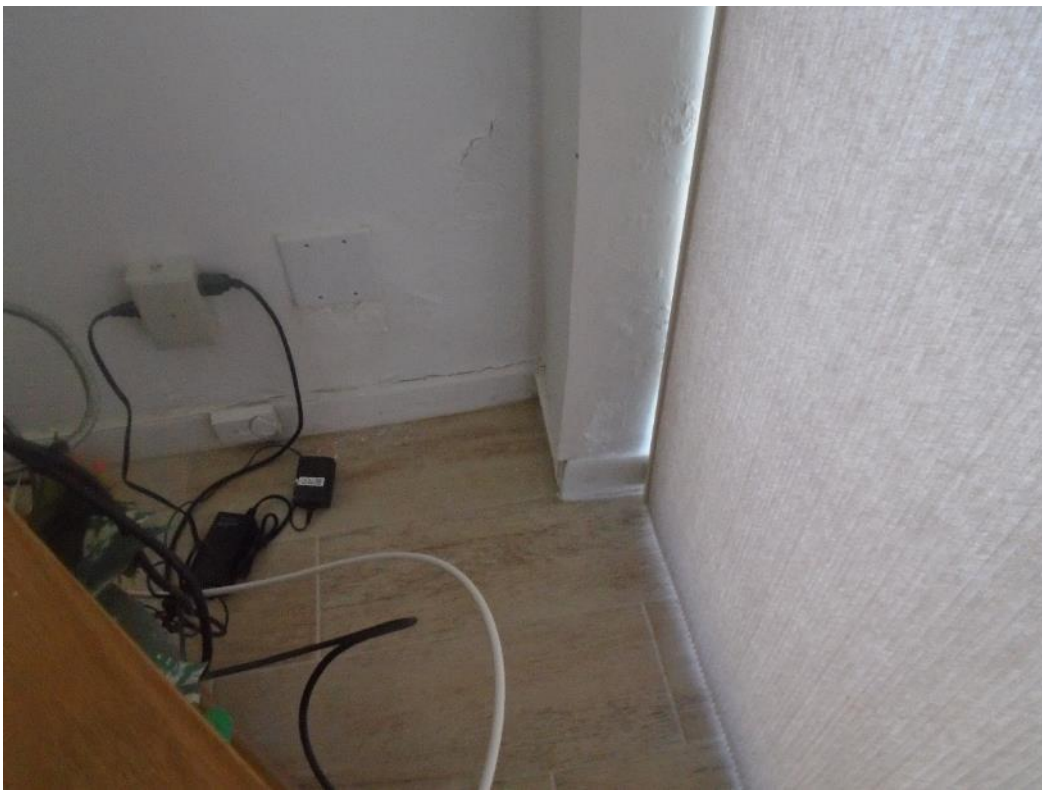
Example view of water intrusion at window opening due to either window failure, sealant failure or structural damage
