# BUILDING INSPECTION SERVICES

March 25 & 26, 2019

Sandpiper Towers Condominium Association, Inc.  
c/o Dennis Smith (President) & Dolores Melton (Treasurer)

205 Highway A1A  
Satellite Beach, Florida 32937

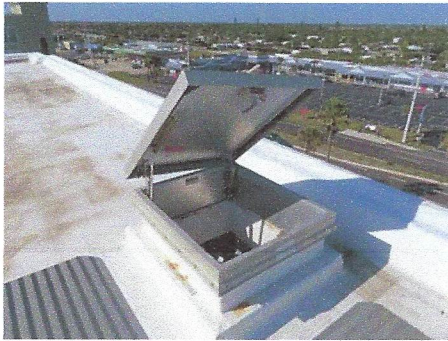
- The south roof access hatch shocks have failed, do not allow opening and closing of the hatch, and need to be replaced.
- The north roof access hatch latch has broken off, does not allow opening and closing of the hatch, and needs to be replaced.
- The roof section exhibits ponding water conditions at numerous locations throughout the roofing system. Standards within the roofing industry hypothesize that prolonged ponding water conditions can reduce useful roof service life by up to 50%. The algae development observed in several areas, indicates that the ponding water conditions remain on the roof surfaces beyond the maximum allowance permitted by the building code, as defined below:

View of south roof access hatch and damaged shocks which prevent proper opening/closing

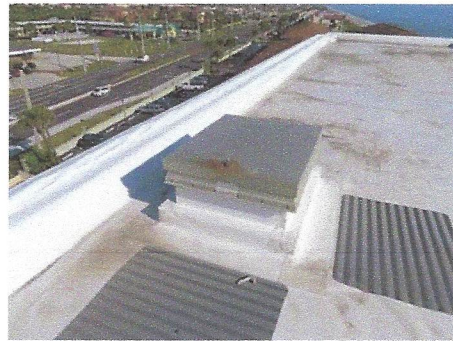
View of north roof access hatch with latch that has broken off

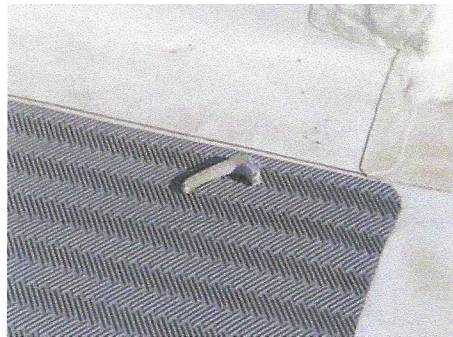
View of latch on roof deck

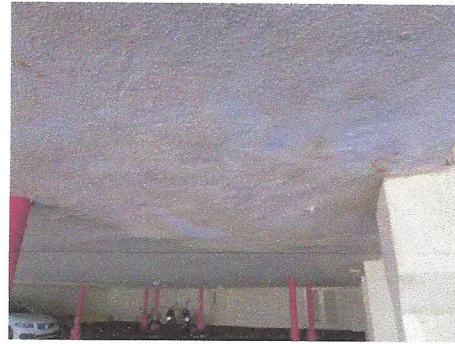
- The lower roof section exhibits evidence of leakage at numerous locations throughout the covered parking garage. The roofing system was installed in 2002, as previously noted above and therefore has exceeded its useful service life. The typical useful service life of built-up tar and gravel roofing systems is generally 12-16 years.

View of typical leakage evidence (water stains) observed at ceiling areas over covered parking

Given the number and/or extent of the individual defects described above, we feel the overall conditions indicate that the present roof covering has lost its integrity and no longer suitable for repairs. Replacement of the roof covering is, therefore, recommended and should include replacement of rotten wood substrate and/or related components, when found.

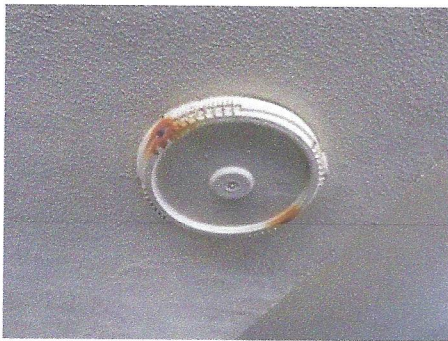
View of leakage evidence through improvised light fixture cover

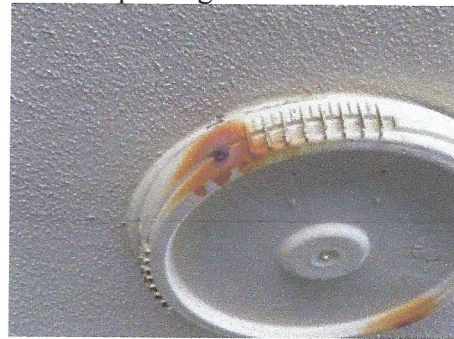
Closer view of leakage evidence through improvised light fixture cover

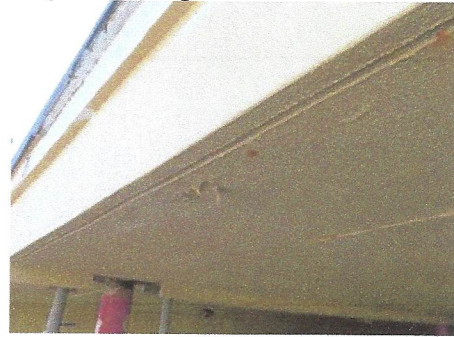
View of reemergence of leakage evidence along north edge after previous refinishing

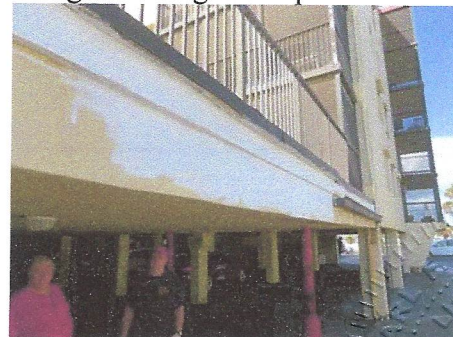
View of reemergence of leakage evidence along north edge after previous refinishing

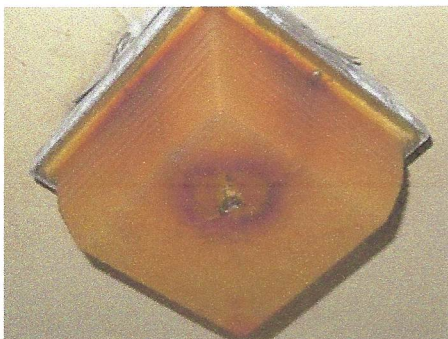
- There are several damaged light fixtures with damaged and/or missing globes or covers in various locations of the south covered parking areas. All such areas should be located and replaced for personal safety and protection of the electrical system.
- The pool equipment room sub-feed panel cover is missing a knock-out blank and a knock-out blank filler should be installed to prevent against contact with energized components.

View of typical damaged light fixture cover in south covered parking area

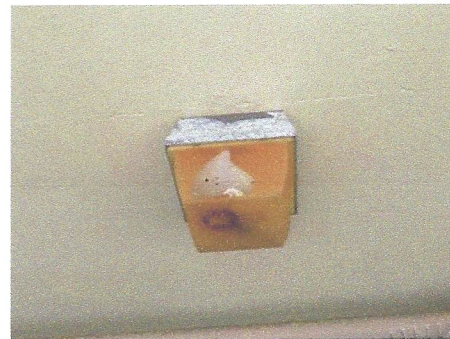
Another view of typical damaged light fixture cover in south covered parking area

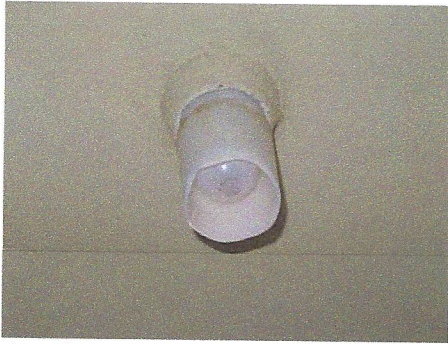
Another view of typical damaged light fixture cover in south covered parking area

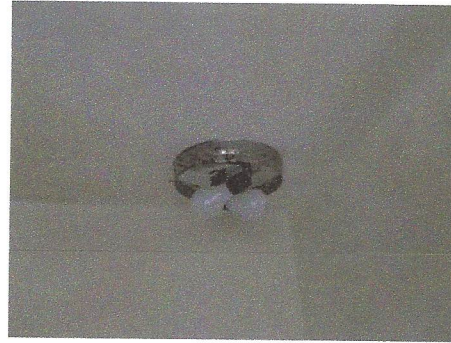
- The second-floor laundry room restroom light fixture has a missing globe which needs to be replaced.
- The maintenance office south wall junction box is open with exposed wiring which should be covered with an appropriate cover plate.

View of typical missing cover at laundry room restroom light fixtures

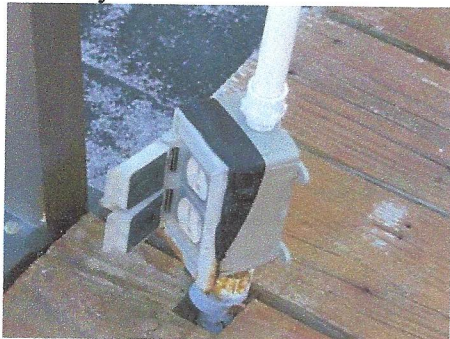
- The rear deck area stairway receptacle weatherproof enclosure has been improperly repaired with tape and requires correction. In addition, the receptacle does not have ground fault protection and needs

View of receptacle weatherproof cover with improper tape repair and absence of ground fault protection

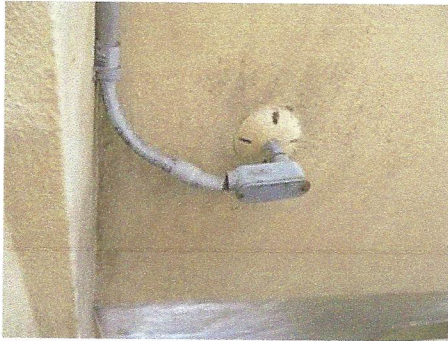
- There was disconnected conduit with exposed wiring at the front carport north side which needs to be repaired.
- The rear deck area stairway light fixture is damaged and needs to be replaced.

View of disconnected conduit with exposed wiring at front carport north side

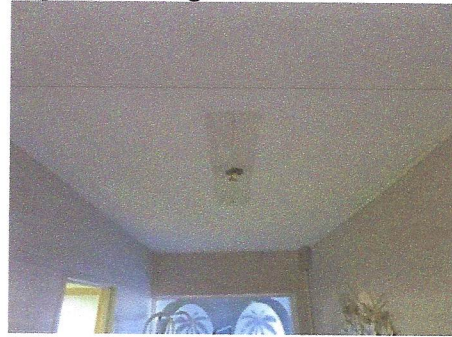
View of open junction box and exposed wiring at ceiling in lobby area

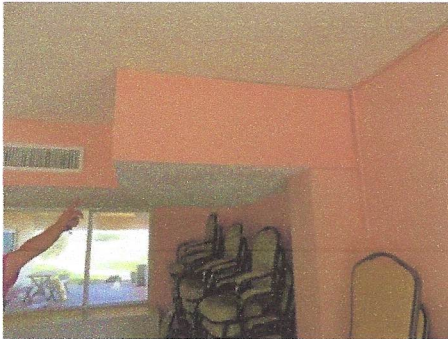
- There was evidence of plumbing component leakage (water damage) observed at the Card Room northeast ceiling/soffit. Representatives of the association indicated the leakage occurs due to back-ups in the cast-iron waste lines.
- There was evidence of current and previous leakage at numerous areas of the cast-iron waste piping observed throughout the covered parking areas at the north and south sides of the structure. Additionally, there are several areas with cracked and heavily corroded cast-iron waste lines. Evidence of previous leakage and improper/temporary repairs were noted at numerous locations.

View of leakage evidence from plumbing components above ceiling in card room

Given the nature of the above noted conditions, it is recommended that the cast-iron waste lines be replaced. Since the repair and estimating process for piping replacement is so labor intensive and since existing conditions after further examination could reveal additional deficiencies and related repair costs, completely reliable estimates for this remedial procedure are not practical. The obtaining of several competitive bids for the required remedial work is recommended.

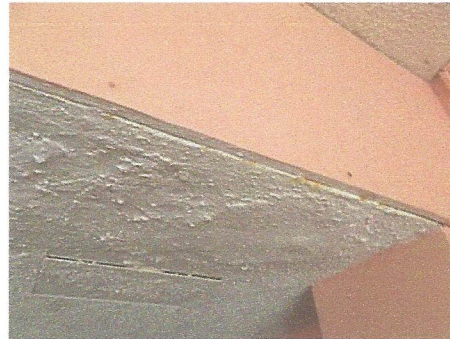
Closer view of leakage evidence which occurs due to back-ups in cast-iron waste piping

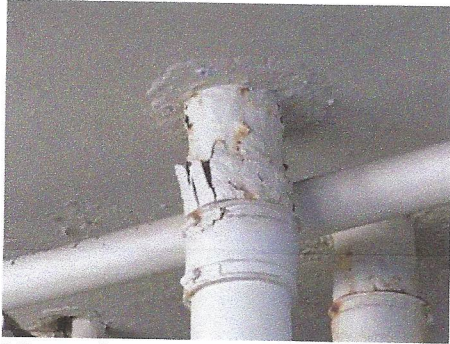
View of typical heavily corroded/deteriorated cast-iron waste piping and repairs evidence

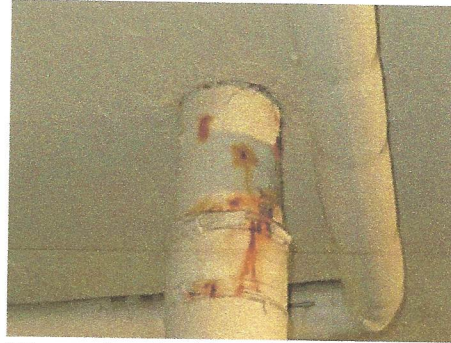
View of typical heavily corroded/deteriorated cast-iron waste piping and repairs evidence

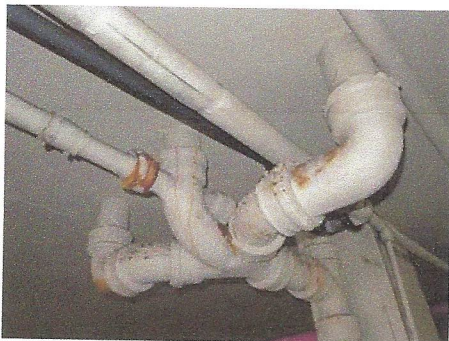
View of typical cast-iron waste piping, from living units, in south covered parking area

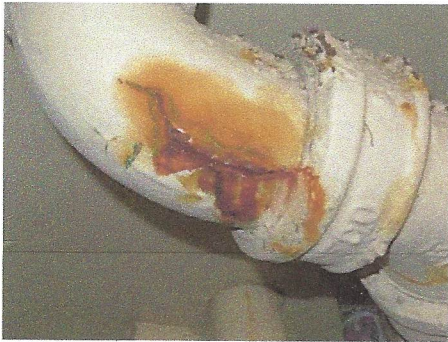
View of typical cracked and deteriorated cast-iron waste piping with evidence of leakage

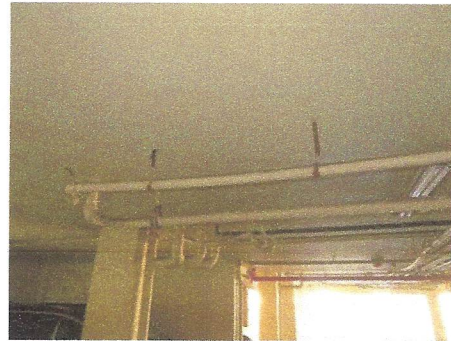
- The supports for various piping, throughout the covered parking areas, have rusted away. All such areas should be located and properly supported to prevent sagging of the lines and undue vibration which can result in damage and/or leakage.
- There were unsupported water supply and waste lines observed in the following locations: pool equipment room, north covered parking area at several locations and south covered parking area at several locations. All such areas should be located and properly supported to prevent sagging of the lines and undue vibration which can result in damage and/or leakage.

View of typical piping supports which have rusted away in covered parking areas

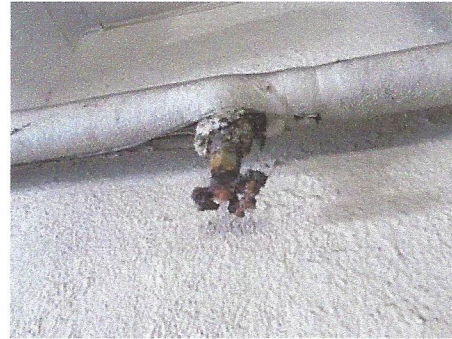
- Most, if not all, of the shut-off valves at the hydronic supply/return lines throughout the covered parking areas have deteriorated valve handles and are inoperable. Replacement of the all affected shut-off valves is recommended.

Another view of typical nonfunctional shut-off valve with deteriorated valve handle at hydronic piping in covered garage areas

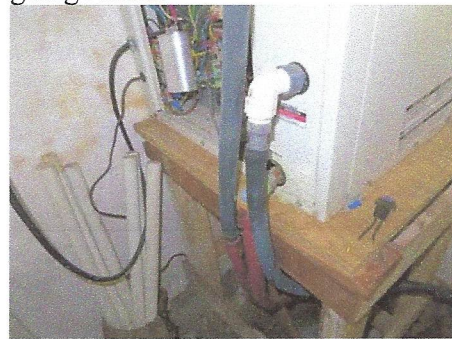
View of typical rubber supply and return lines which should be routinely checked for wear/deterioration

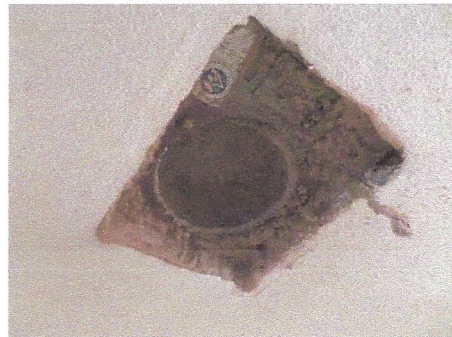
- Many of the laundry room restroom exhaust fans have been removed. The exhaust fans which have not been removed are not function. Replacement of the all exhaust fans is recommended, should the restrooms be restored for use.

View of typical missing exhaust fan assembly in laundry room restrooms

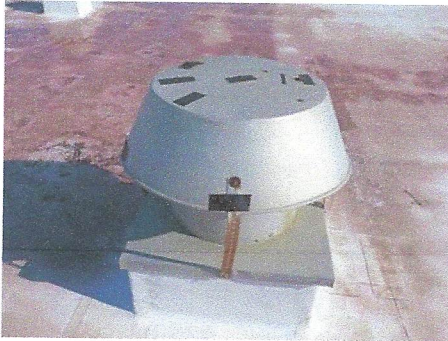
- Most, if not all, of the rooftop ventilation domes/covers have been improperly repaired and/or secured with duct tape or the like. There were also numerous areas with corroded or missing fasteners which permit moisture intrusion into the structure. The ventilation domes/covers should be properly secured in manner which provides protection against high velocity windstorms as well as moisture intrusion. If the ventilation domes/covers cannot be suitably repaired/secured, then replacement of the ventilation assembly is advised.

View of typical improper duct tape repairs at ventilation dome/cover

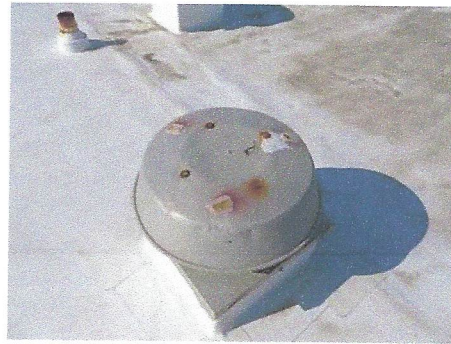
View of typical ventilation dome/cover which has rusted through and allows moisture intrusion into the structure

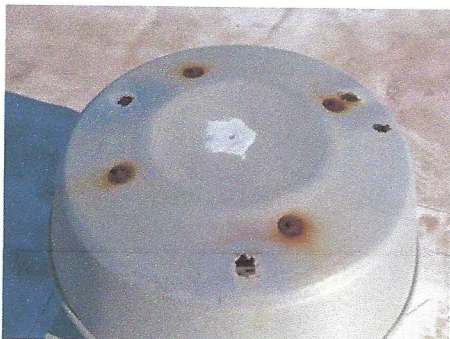
Another view of typical ventilation dome/cover which has rusted through and allows moisture intrusion into the structure

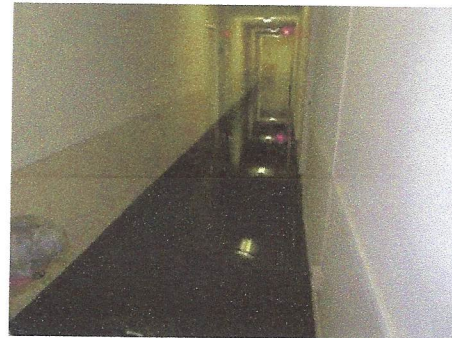
Notation: The evaluation of the mechanical systems within the confines of the individual living units was not part of this inspection, however leakage occurred from the supply lines at one of the unit air handlers during the time of this inspection, which resulted in inundation of the common areas and leakage into the lower floors.

Another view of inundation on fourth-floor

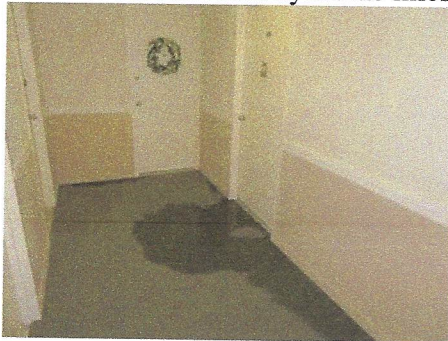
View of leakage at third-floor from above unit

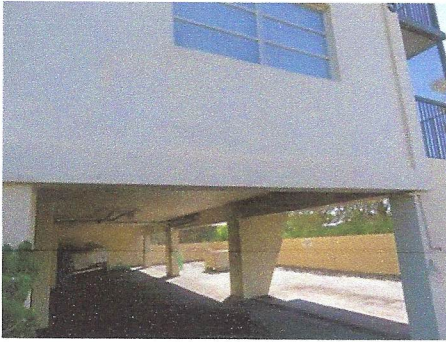
- Spalling conditions were visible at this structure in the following locations: south covered parking area ceiling/soffit over "Garrett" parking space, south covered parking area beam over southwest entry, south covered parking area ceiling/soffit over "Smith" parking space, south covered parking area south beam, north covered parking area ceiling and beam adjacent to #401, unit #505 balcony at corner, south covered parking area at the bottom of several columns, north and south covered parking area ceiling/deck at various plumbing penetrations, exterior north side column adjacent to barbecue area, exterior east side window sill north of card room and exterior north side headers/lintels over some of the second, third and fourth-floor windows. In addition to the above noted areas, there were numerous balconies with cracks at the corners and along the edges which should be sounded and/or opened to ascertain whether spalling is present.

View of spalling condition at southwest beam over entry into south covered parking area

"Spalling" is a condition where the reinforcing steel rods within the concrete rust or scale, causing outward pressure upon the concrete and forcing the structural member to weaken at that point. We recommend the condition be repaired by breaking off any loose concrete, exposing the rebar to inspection, wire brushing the steel and/or replacing any steel that has lost 25% of its diameter and then using gunite or a high compression cement to replace the area of damaged concrete.

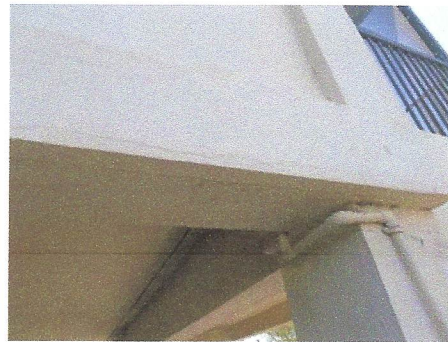
Closer view of spalling conditions

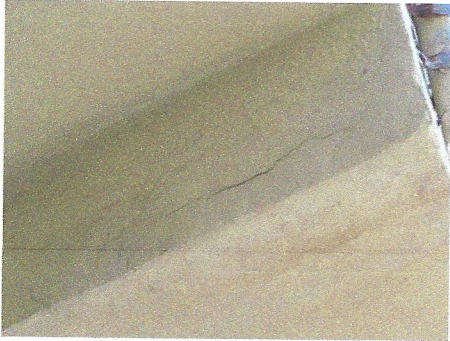
Closer view of spalling evidence and patching

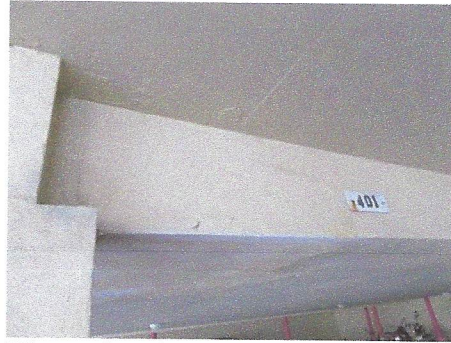
View of spalling condition at north covered parking area ceiling/deck near #401

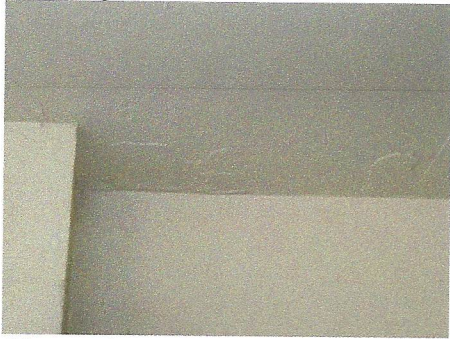
Closer view of spalling condition at ceiling/deck in north covered parking area

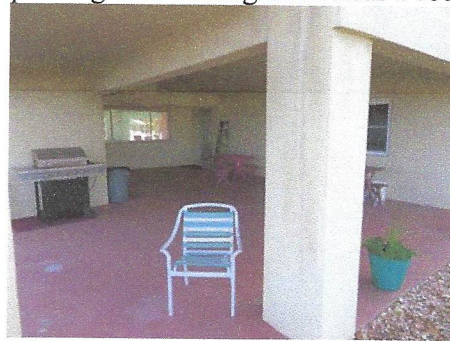
View of barbecue area and column with spalling condition

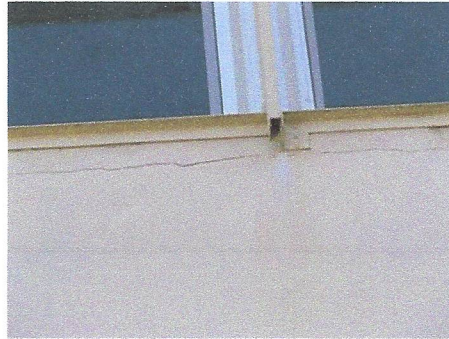
Closer view of spalling condition at sill below window

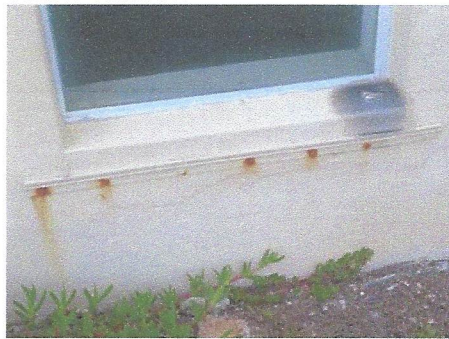
Closer view of spalling condition on sill below window

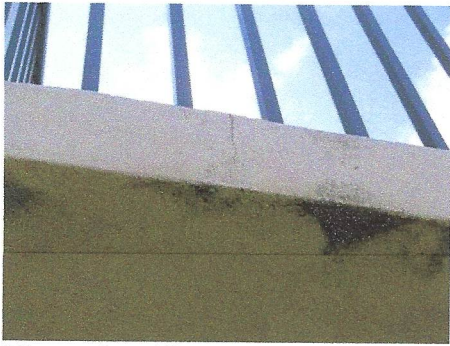
View of spalling condition at edge of landing

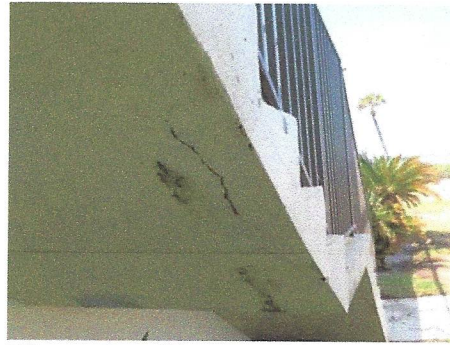
View of spalling condition at underside of stairway

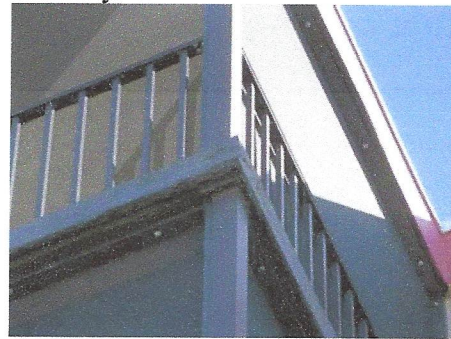
View of typical cracks on balcony corners which should be opened and/or sounded for spalling

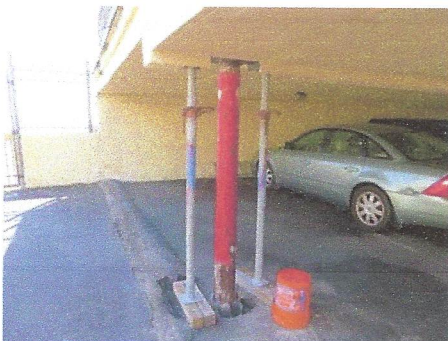
View of north covered parking area northeast column which has rusted through and needs to be replaced

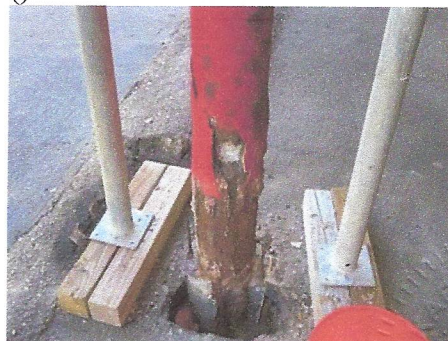
Closer view of column which and foundation which need to be replaced

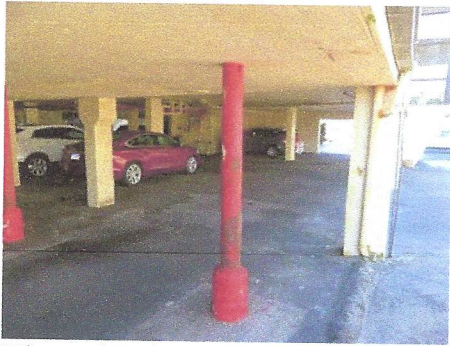
View of typical north covered parking area column with corrosion which needs to be wire brushed and protected with rust inhibitive

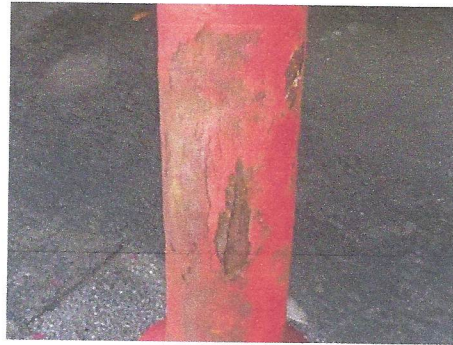
Closer view of typical corrosion on north covered parking area columns

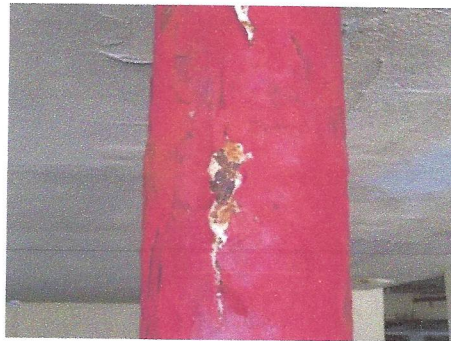
Closer view of typical corrosion on north covered parking area columns

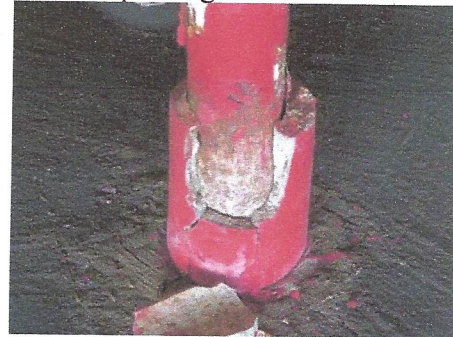
Closer view of typical corrosion on north covered parking area column

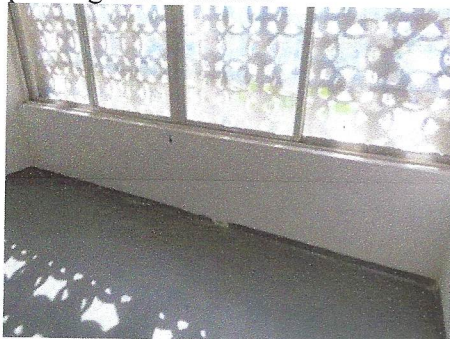
View of typical moisture penetration evidence around window openings in stairway

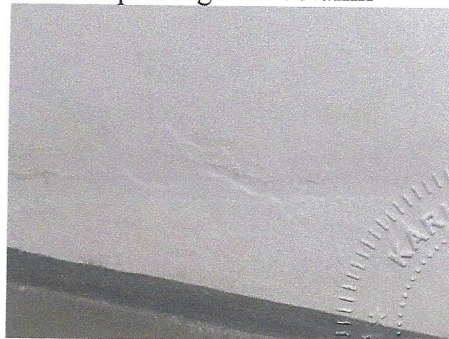
Closer view of moisture penetration evidence

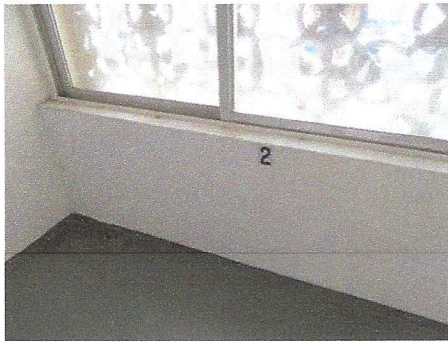
View of typical moisture penetration evidence around window openings in stairway

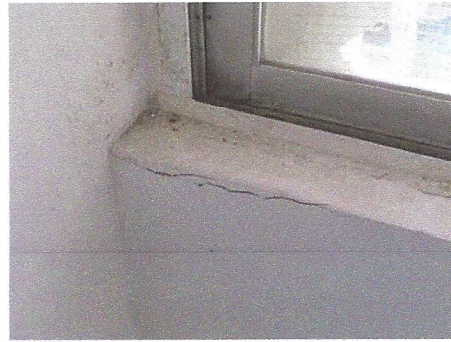
Closer view of moisture penetration evidence

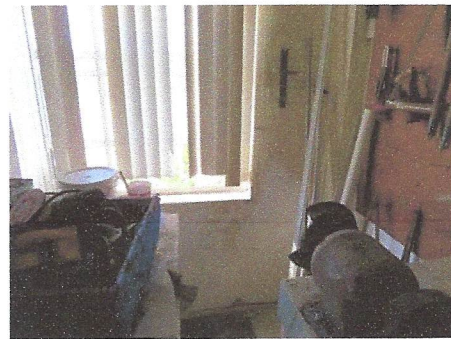
View of moisture penetration evidence at maintenance office wall around window

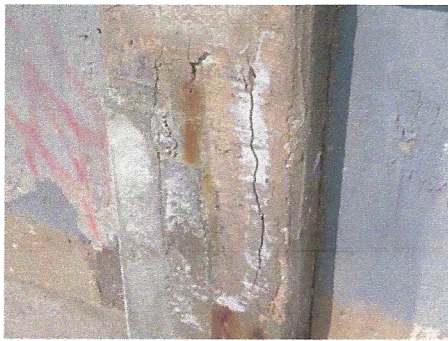
View of typical spalling condition on seawall column

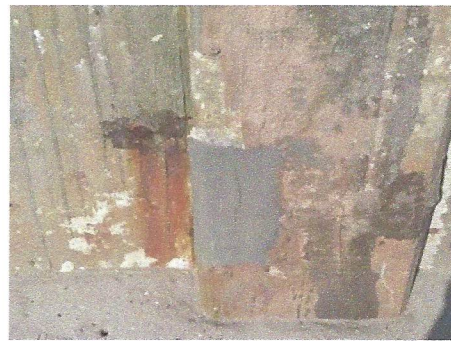
View of typical spalling condition on seawall column

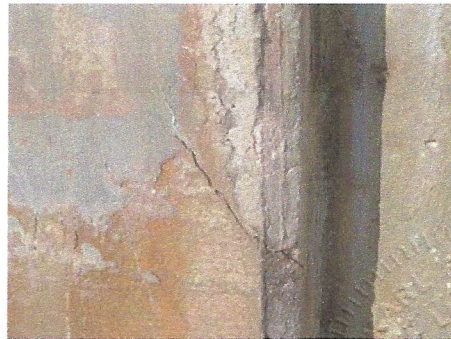
View of typical spalling condition on seawall column

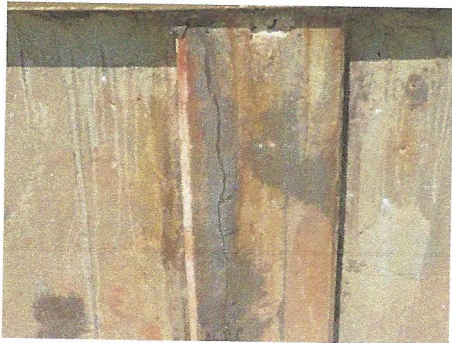
View of typical spalling condition on seawall column

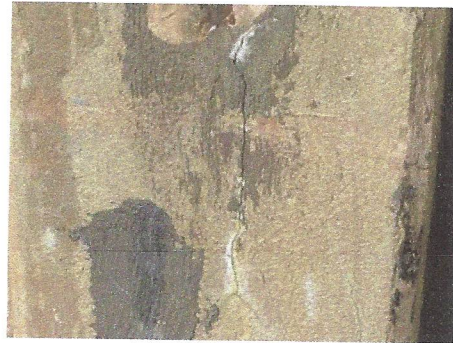
Closer view of typical spalling condition on seawall column

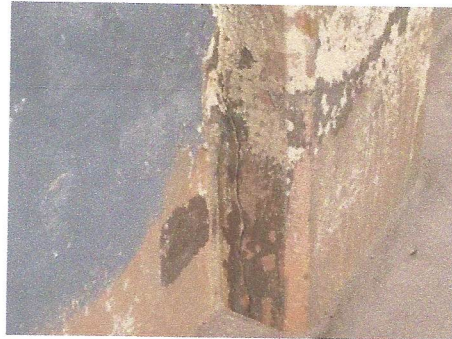
Closer view of typical spalling condition on seawall column

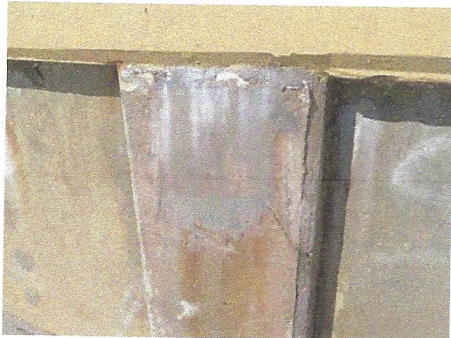
Closer view of typical spalling condition on seawall column

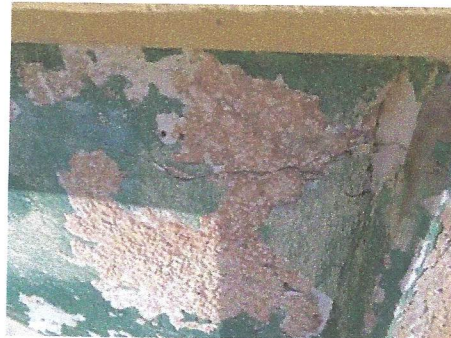
View of typical cracks associated with spalling at seawall panels

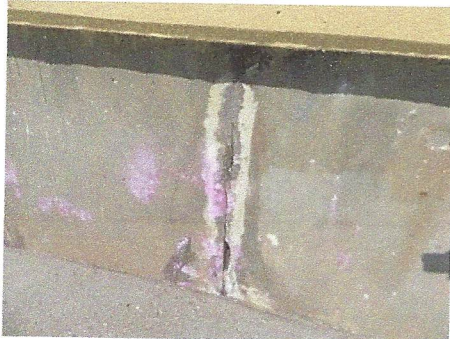
View of typical open joint in seawall panels which need to be properly sealed to prevent washout of backfill

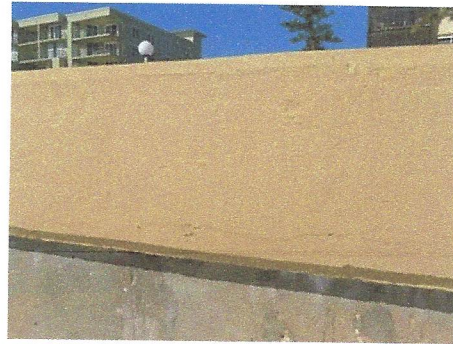
View of spalling evidence at seawall cap at east side

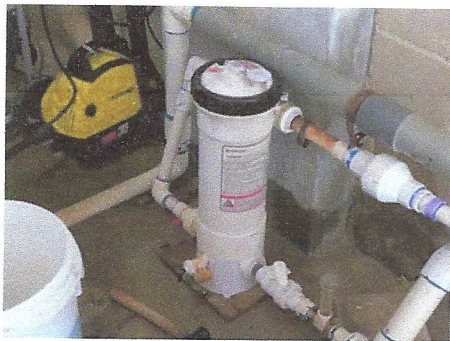
View of chlorinator cell with leakage at top cover

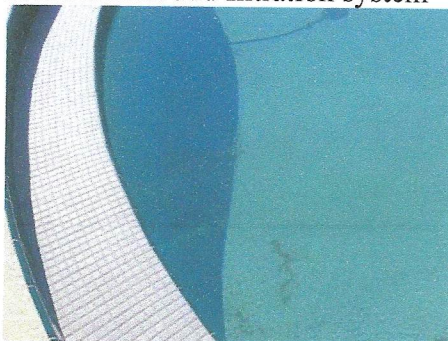
View of excessive bubbling from return jets which is an indication of leakage on the suction side

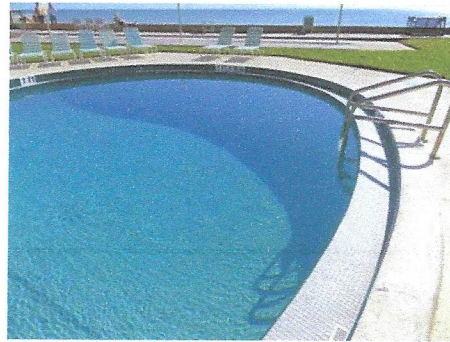
View of perimeter drainage shelf which leaks, as per building maintenance personnel
