Sandpiper Towers Condominium

Condition Survey Report Exterior Building and Balconies

Prepared By
James E. Emory, P.E.
Florida Registered Professional Engineer
Special Inspector #60965

November 11, 2019

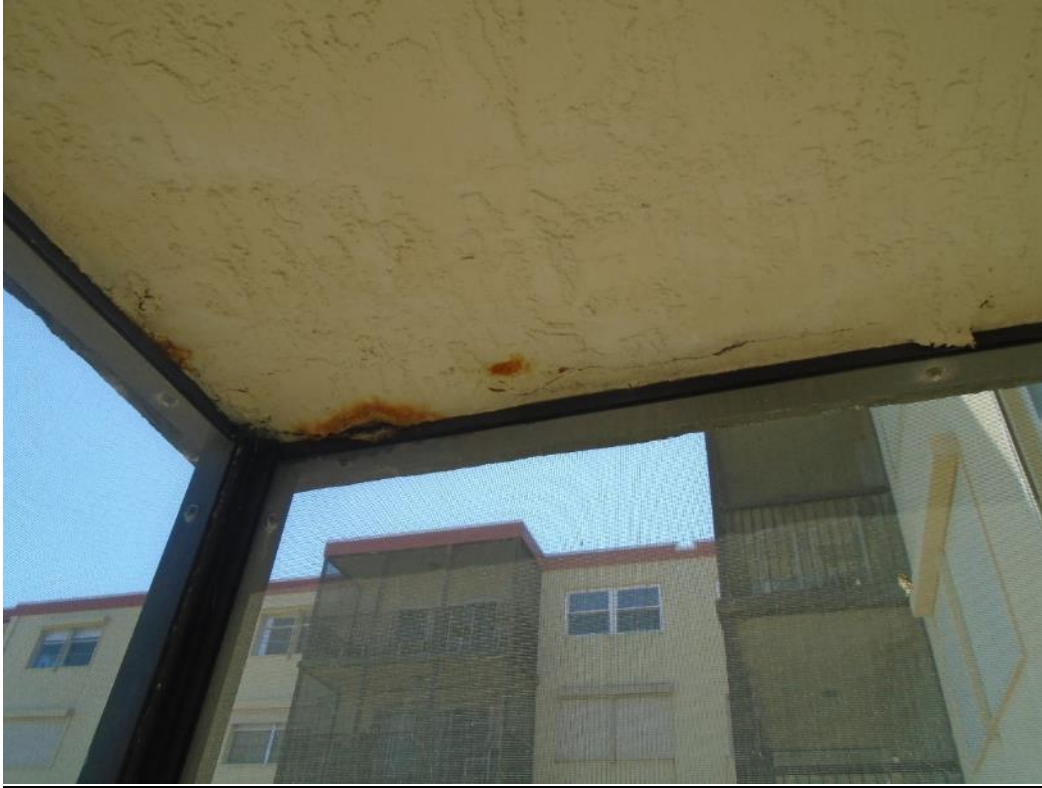
Example view slab edge Concrete spalling due to reinforcing steel corrosion

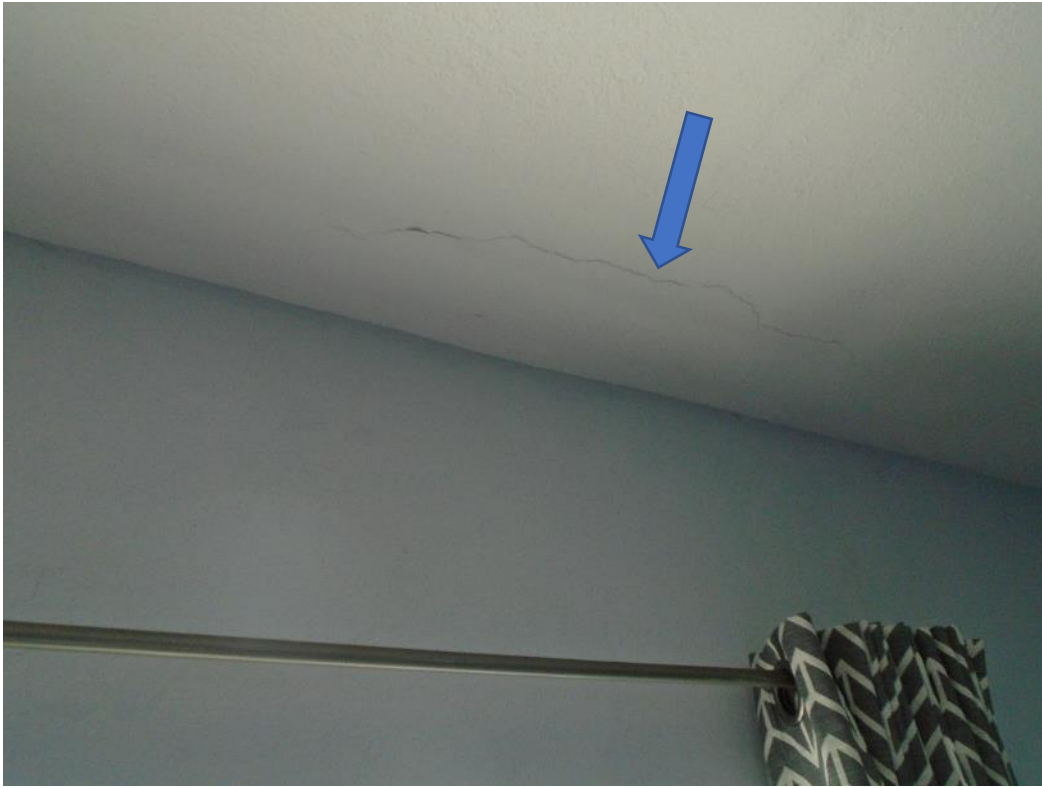
Example view Interior Ceiling Concrete spalling due to reinforcing steel corrosion

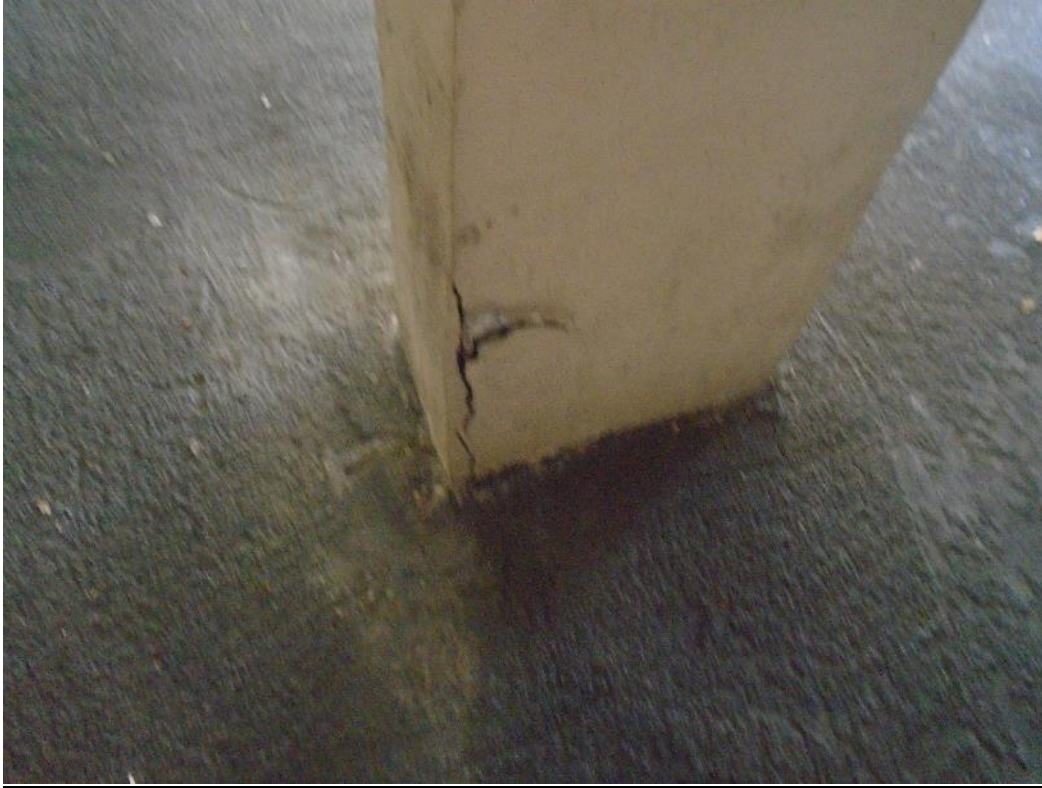
Example view Garage Column Concrete spalling due to reinforcing steel corrosion

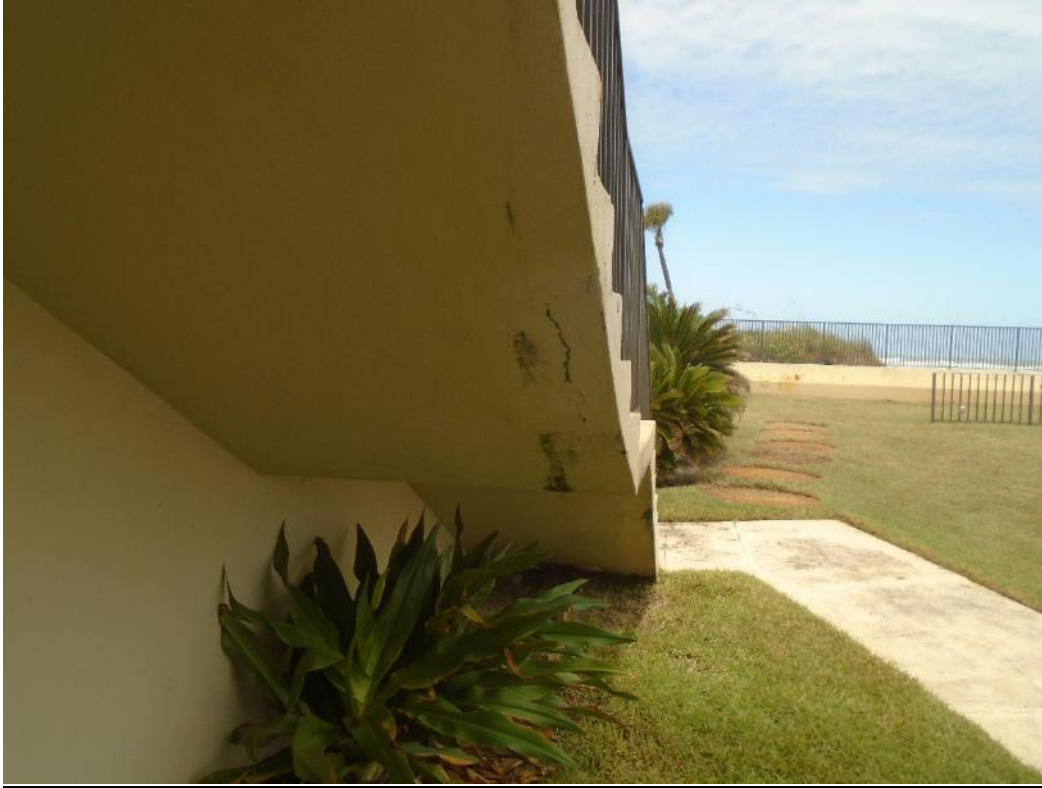
Example view Stairs Concrete spalling due to reinforcing steel corrosion

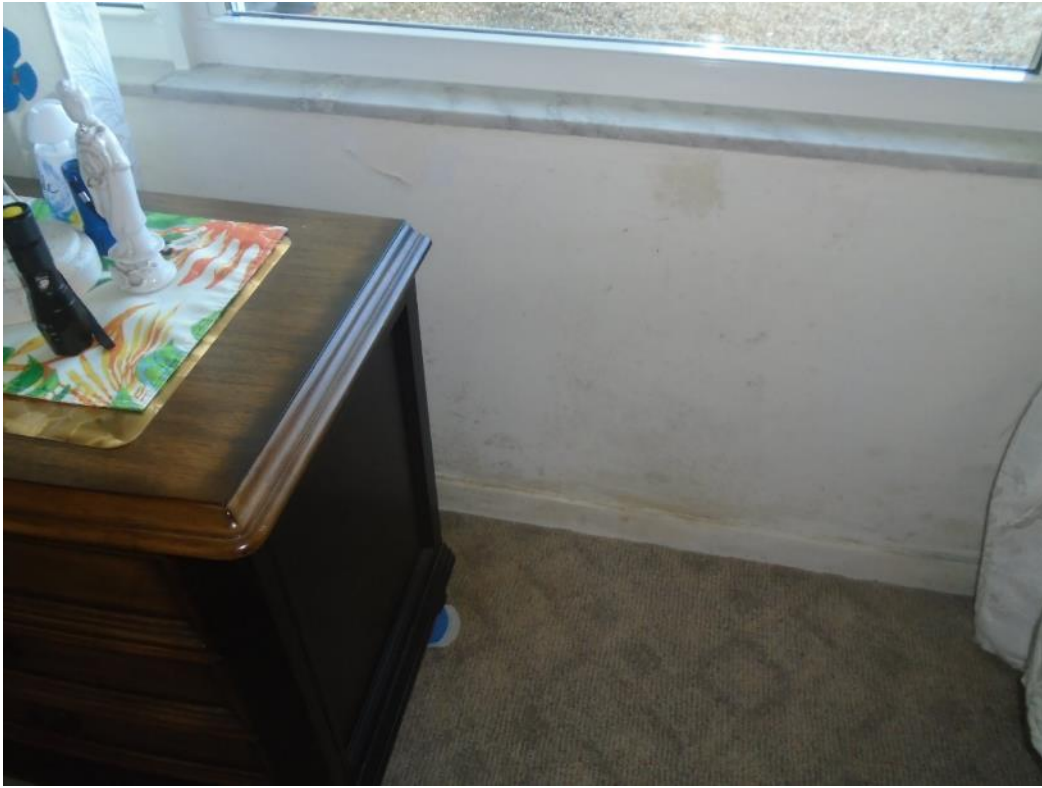
Example view of water intrusion at window opening due to either window failure, sealant failure or structural damage

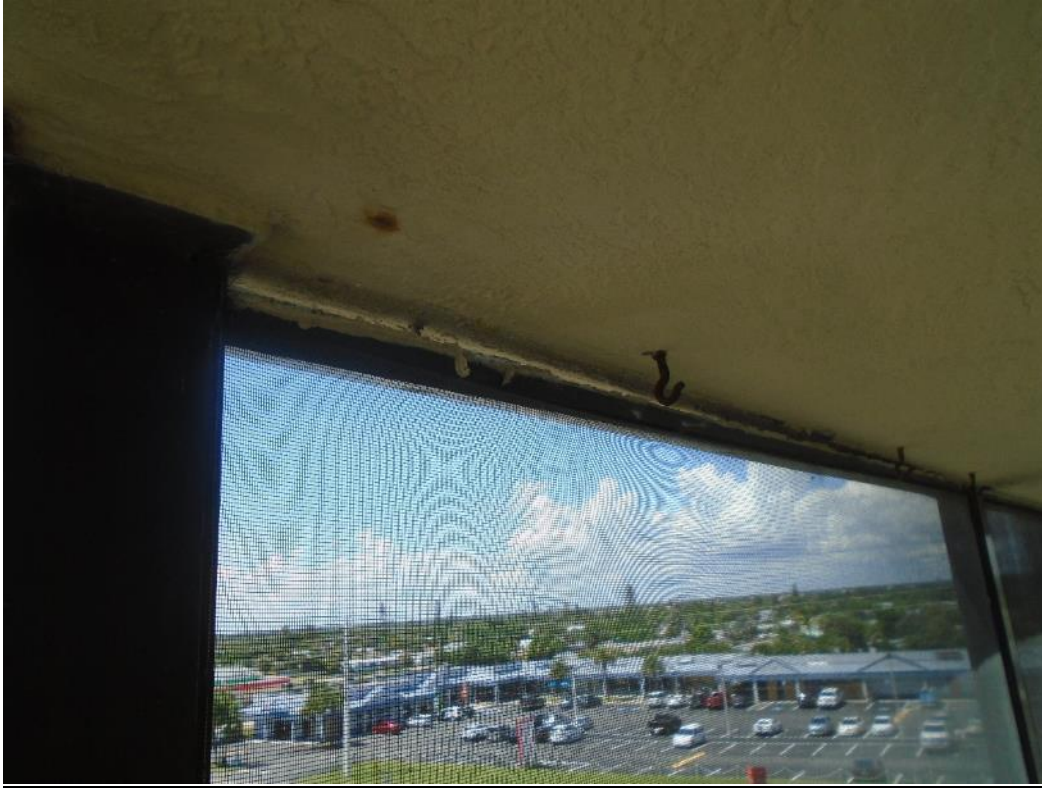
Example view of screen frame fastener deterioration

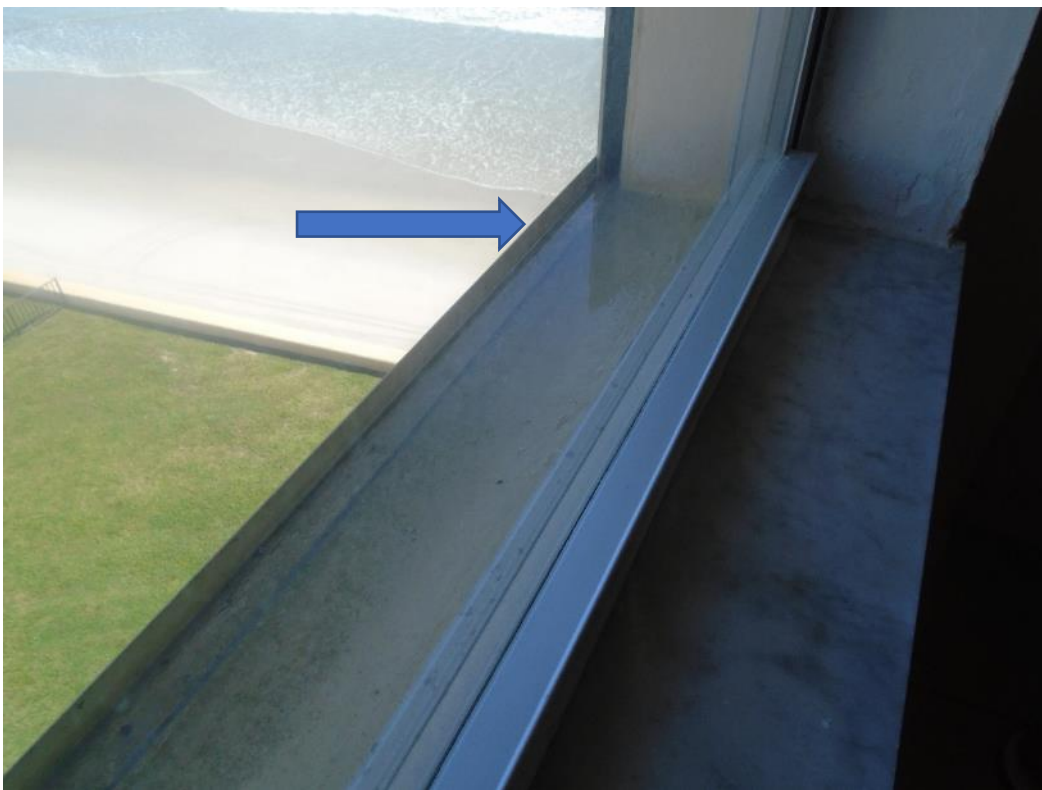
Example view of window shutter track inhibiting drainage off of sill

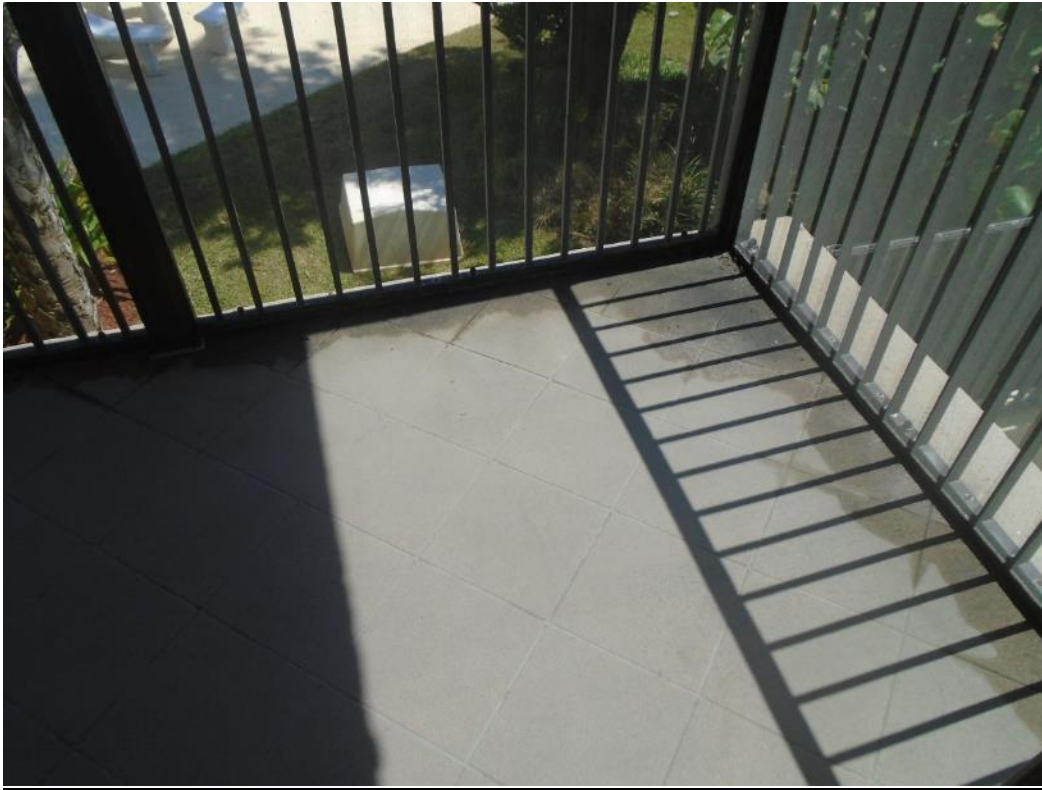
Example view of balcony drainage inhibited by the screen framing

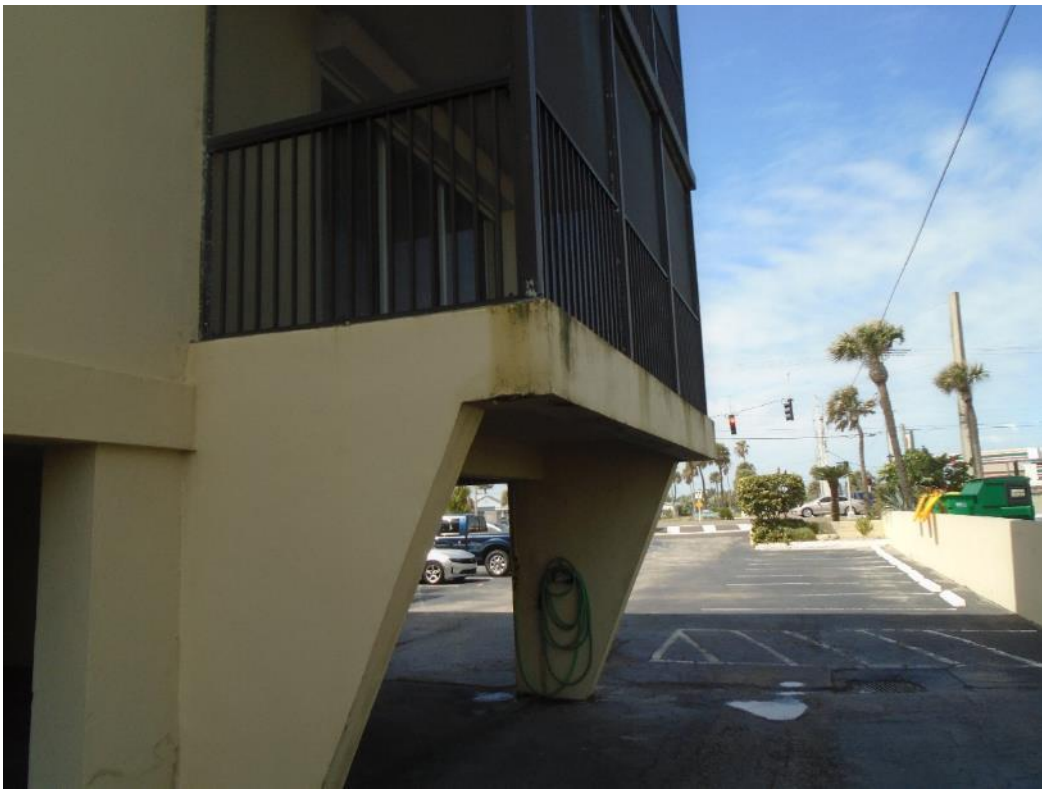
Example view of stucco and paint damage due to inhibition of balcony drainage at screen frame tracks

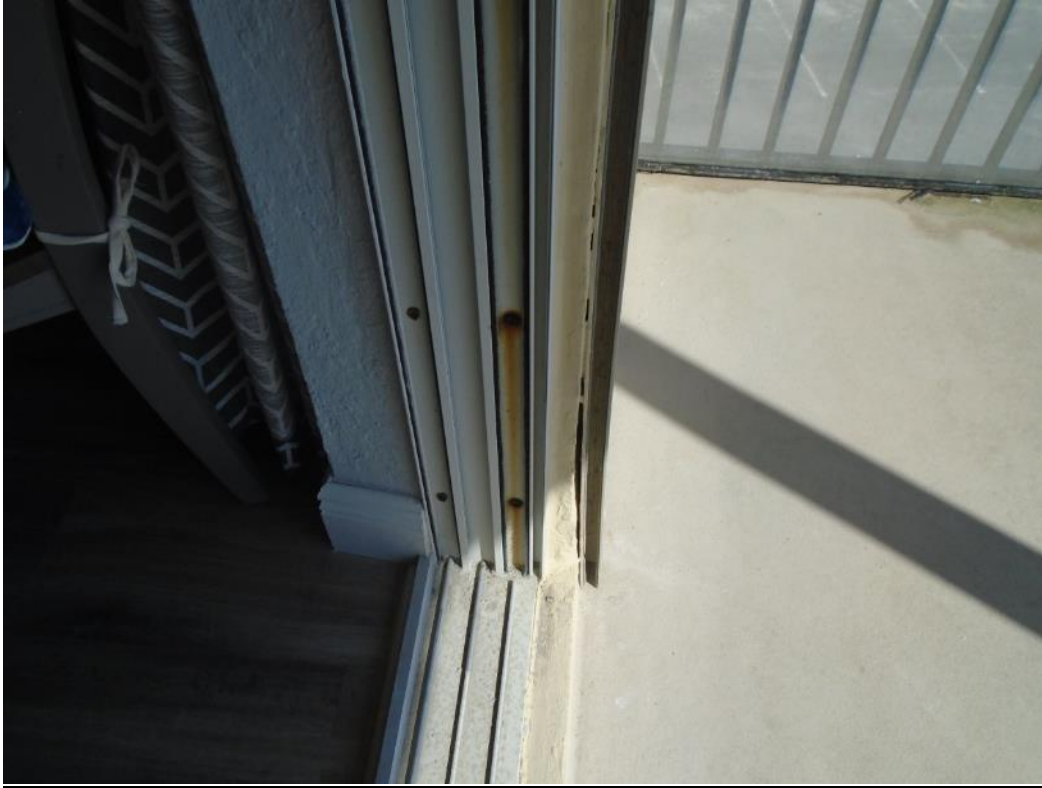
Example view of corroding sliding glass door fasteners

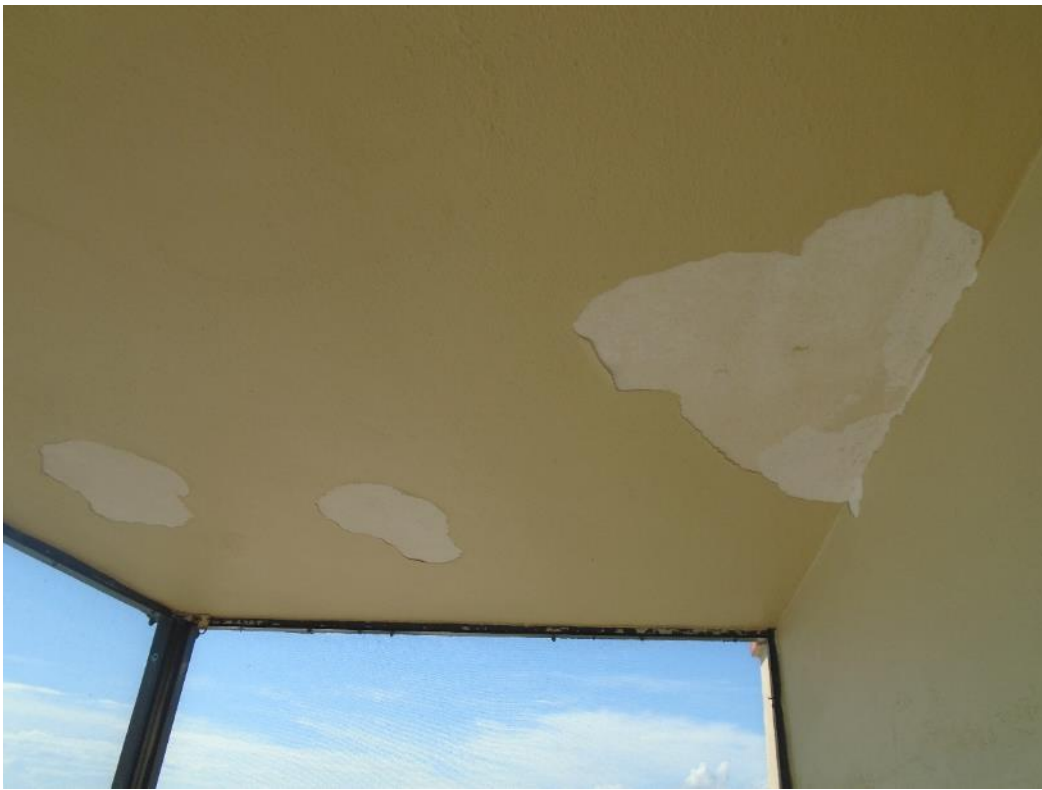
Example view of paint loss of adhesion-improper application of elastomeric on balcony ceilings

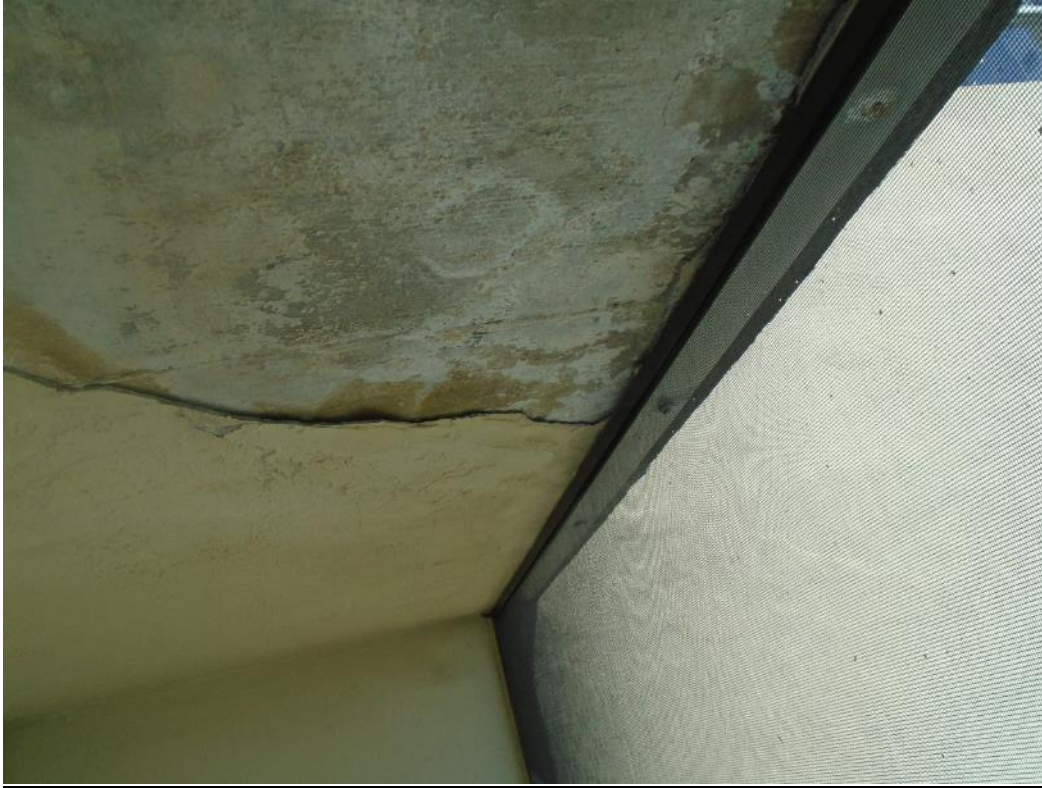
Example view of stucco loss on balcony ceiling due to poor drainage at screen frame above

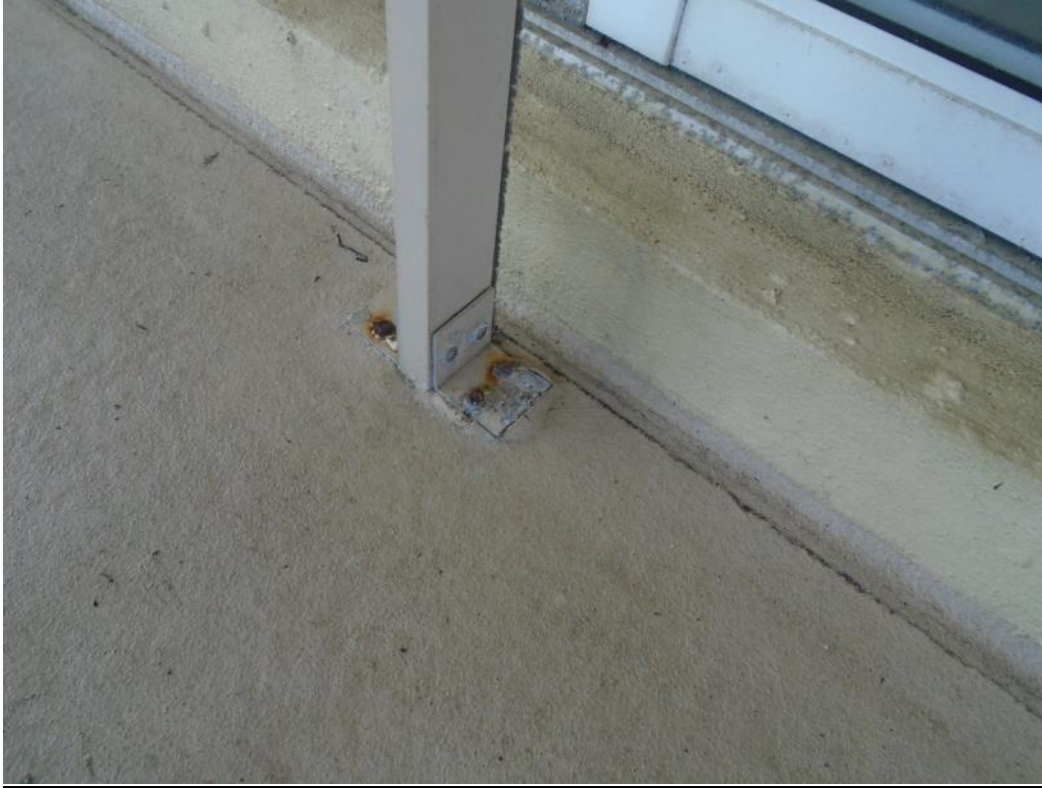
Example view of miscellaneous corroded fasteners

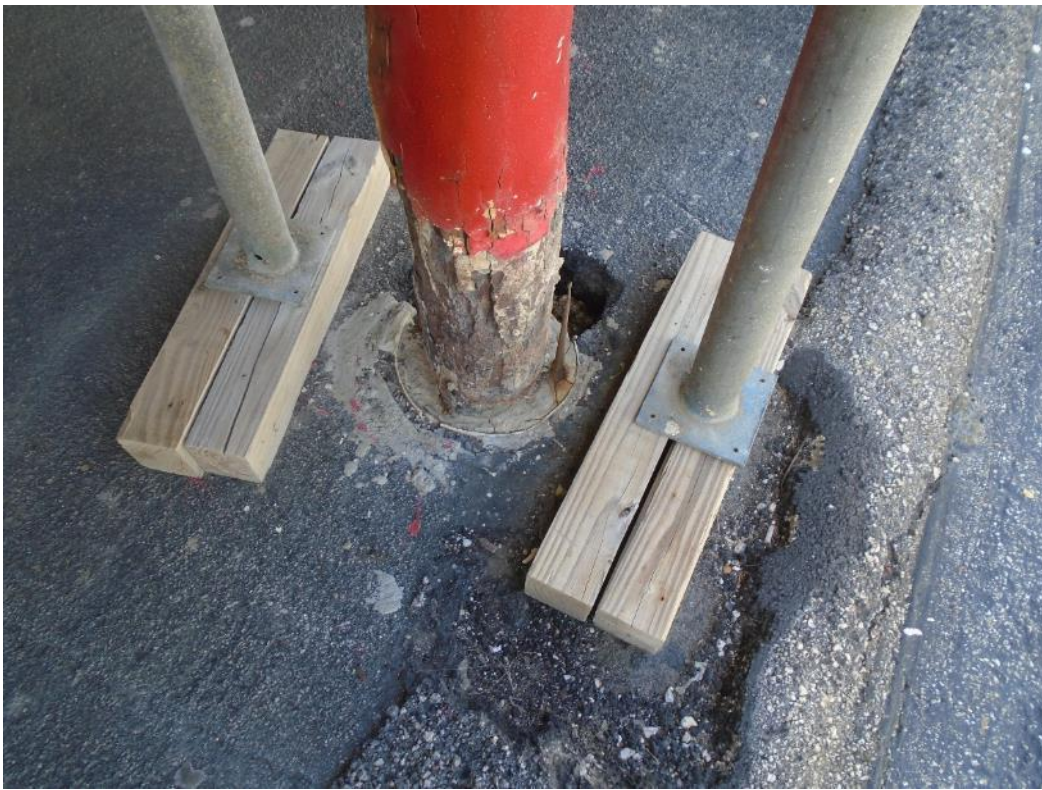
Example view of corroded steel garage support columns

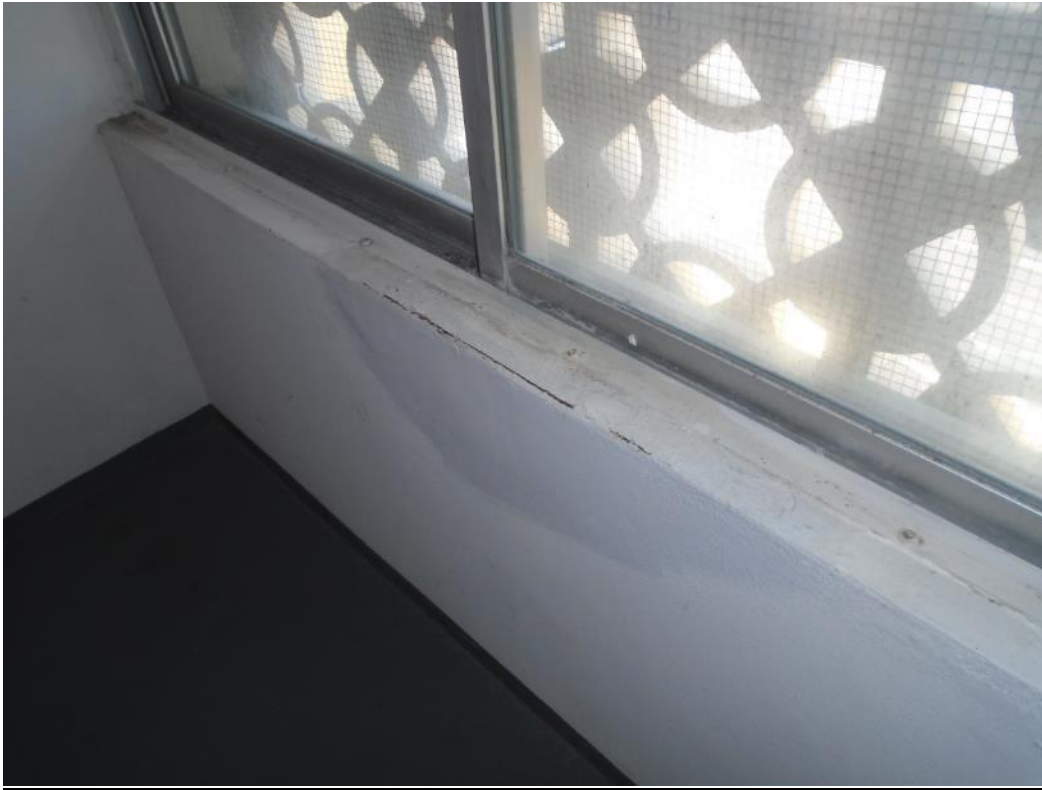
Example view of water intrusion damage behind decorative block windows

- e. Paint and waterproof exterior walls, including interior balcony walls before screens are installed. Replace the west elevation decorative block with a new design if desired.**

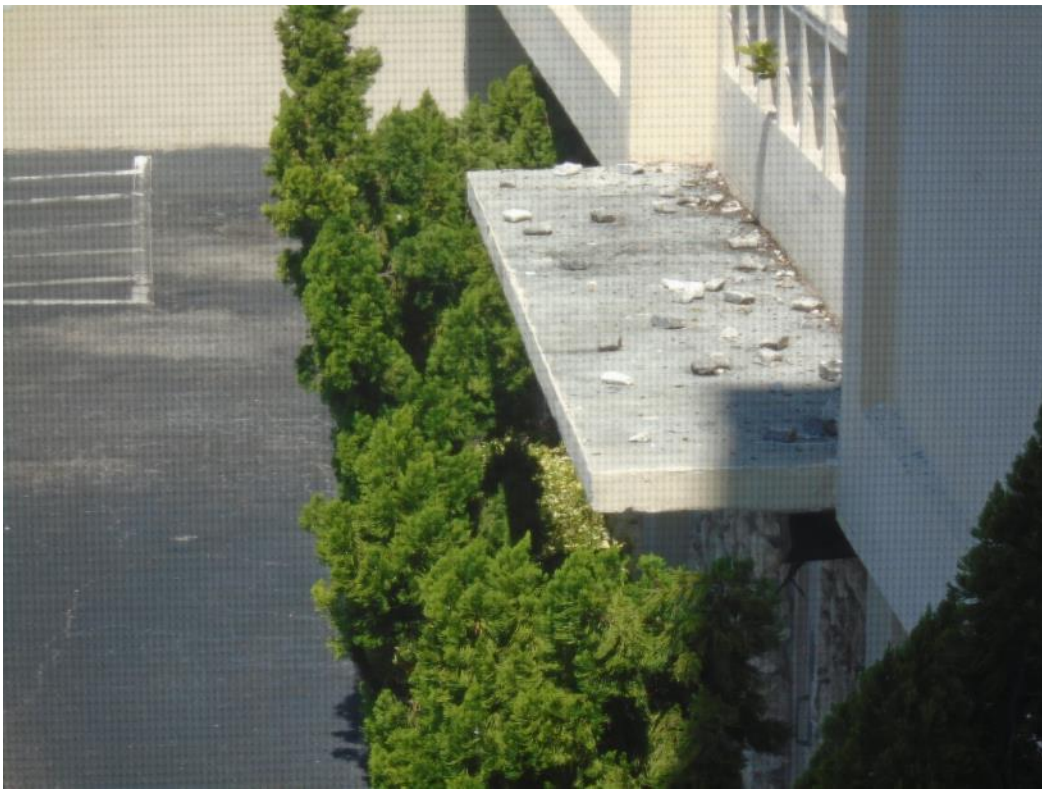
Example view of falling debris from decorative block deterioration

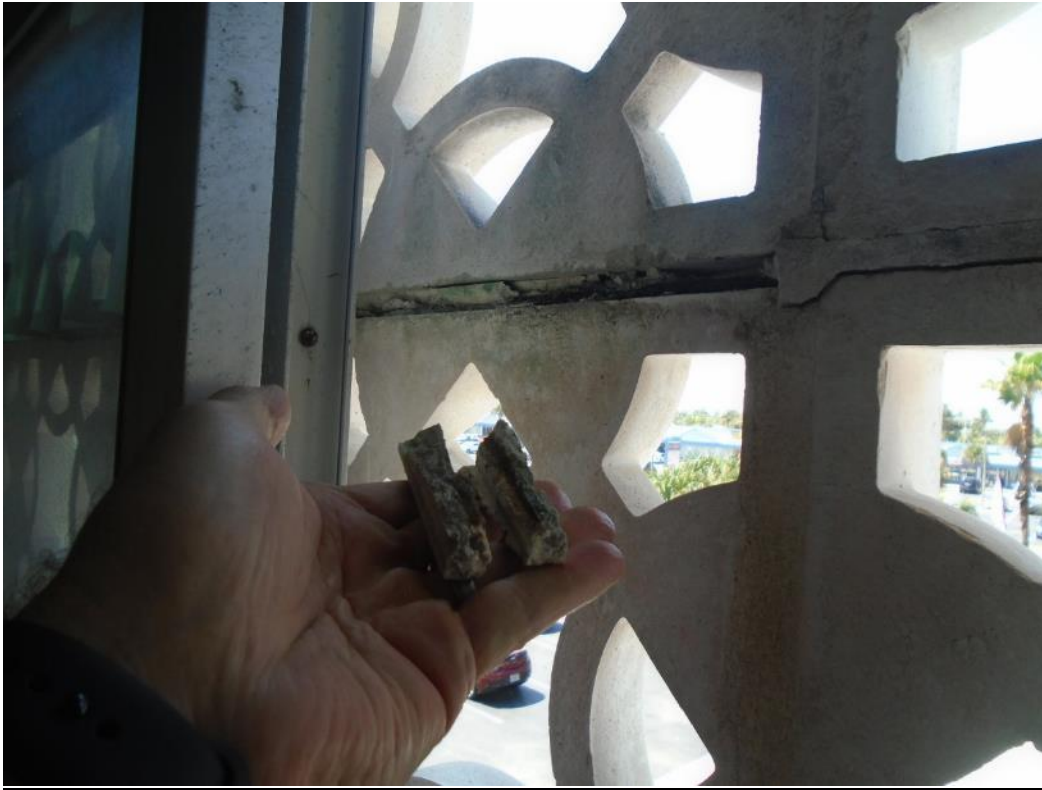
Example view of decorative block deterioration and corrosion

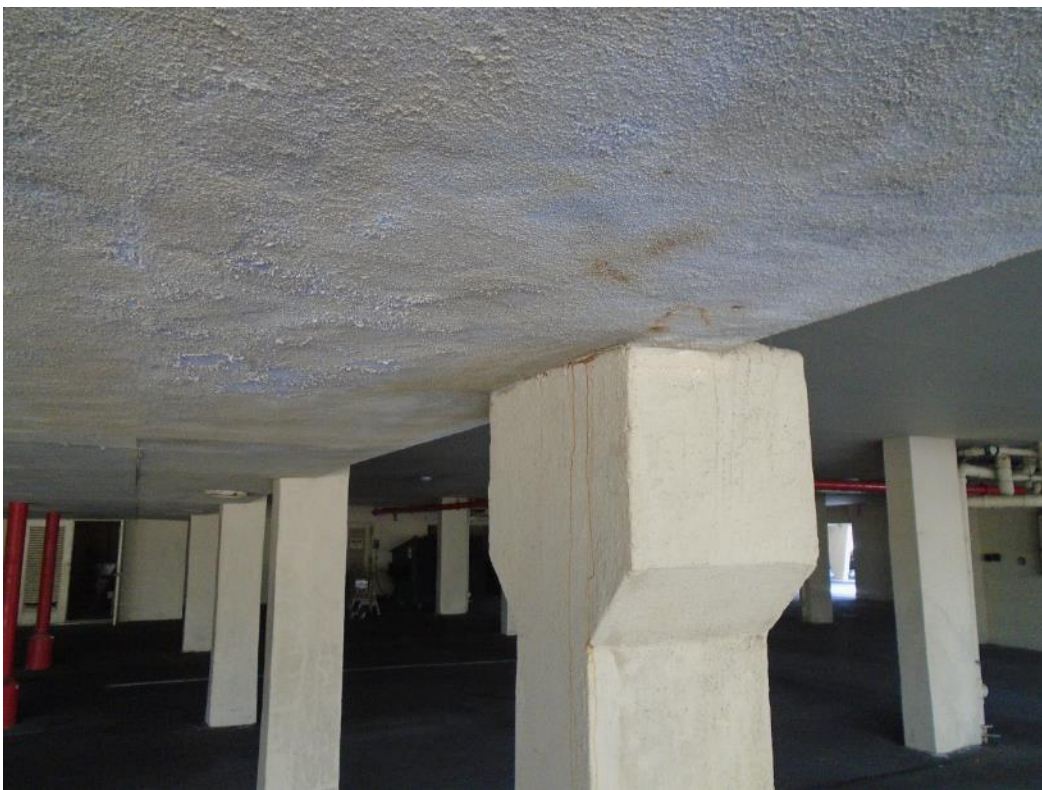
Visual evidence of long term water intrusion from northeast garage roof under balconies

- d. Replace the northeast garage roof including all needed substrate structural repairs, properly designed to accommodate the observation recreation deck and the three private balconies.**

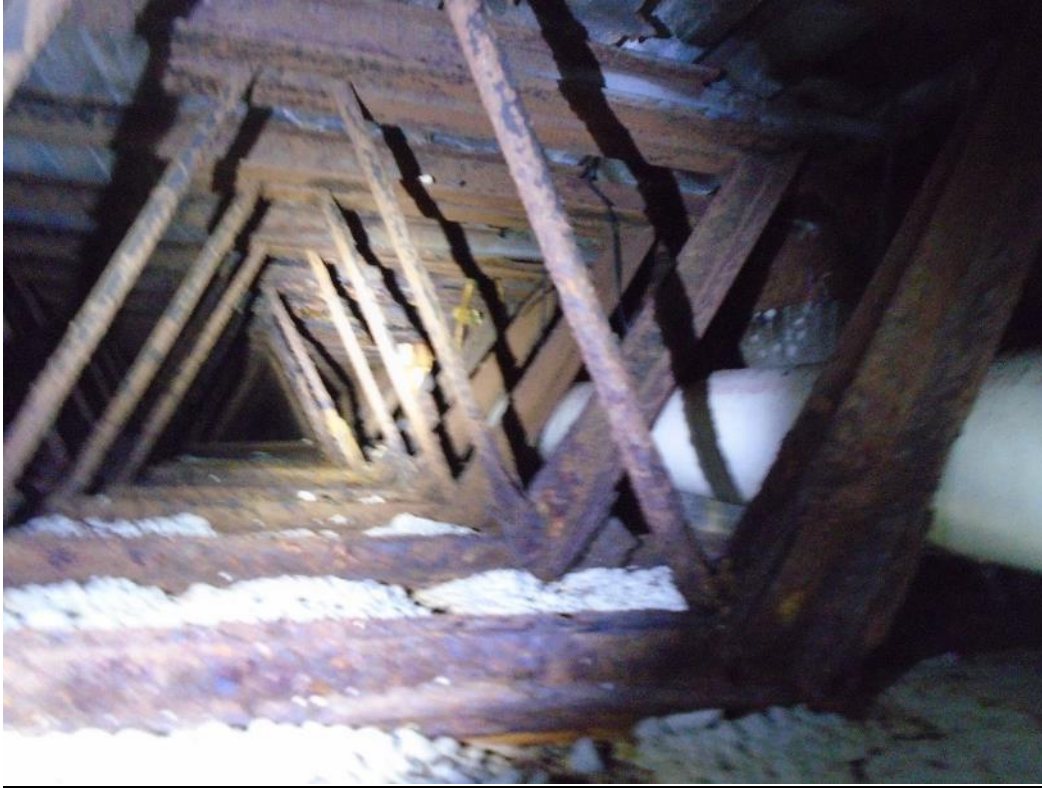
Example view of corroded substructure under northeast garage roof balconies

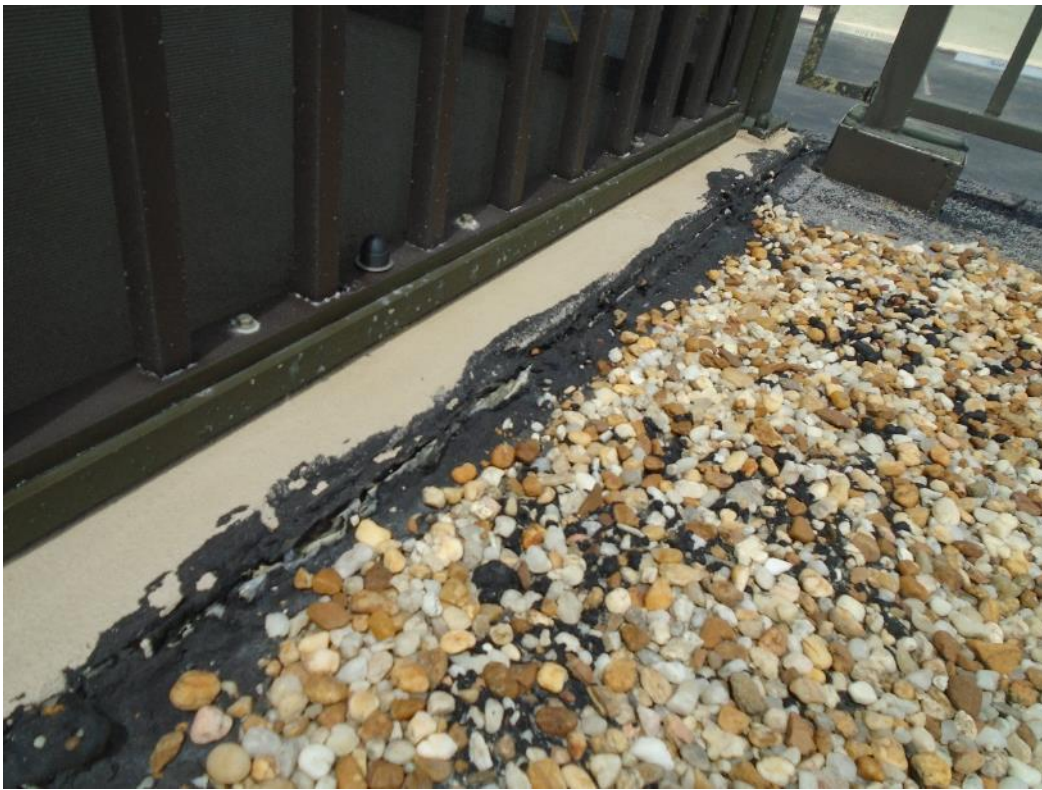
Example view of questionable flashing at roof mounted balcony over garage
