# BUILDING INSPECTION SERVICES

March 25 & 26, 2019

Sandpiper Towers Condominium Association, Inc.  
c/o Dennis Smith (President) & Dolores Melton (Treasurer)

205 Highway A1A  
Satellite Beach, Florida 32937

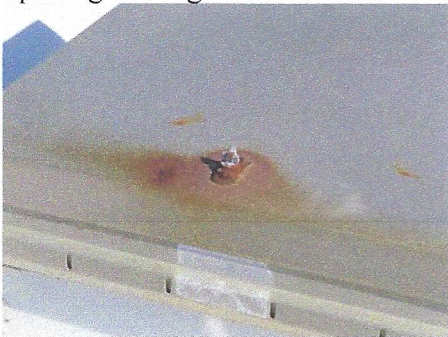
- The south roof access hatch shocks have failed, do not allow opening and closing of the hatch, and need to be replaced.
- The north roof access hatch latch has broken off, does not allow opening and closing of the hatch, and needs to be replaced.
- The roof section exhibits ponding water conditions at numerous locations throughout the roofing system. Standards within the roofing industry hypothesize that prolonged ponding water conditions can reduce useful roof service life by up to 50%. The algae development observed in several areas, indicates that the ponding water conditions remain on the roof surfaces beyond the maximum allowance permitted by the building code, as defined below:

Closer view of latch that has broken off

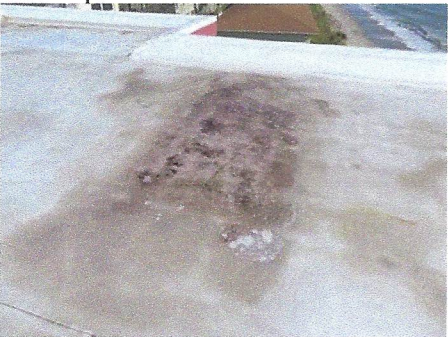
View of typical ponding water and algae development on main roof surfaces

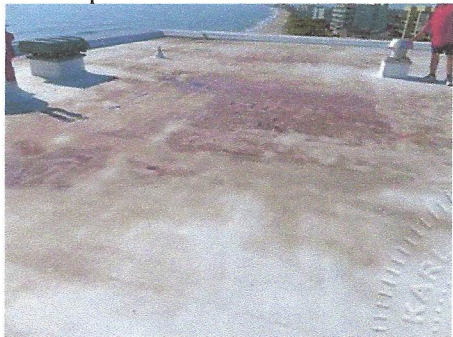
View of typical ponding water and algae development on main roof surfaces

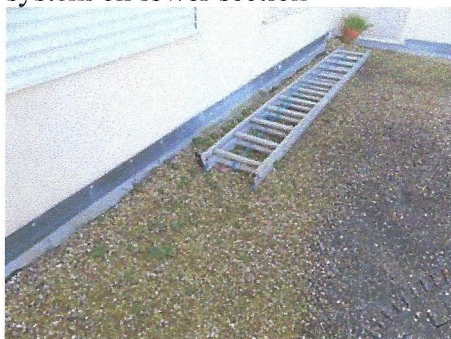
The lower roof section exhibits ponding water conditions at numerous locations throughout the roofing system. The algae development observed in several areas, indicates that the ponding water conditions remain on the roof surfaces beyond the maximum allowance permitted by the building code, as defined below:

View of typical ponding water and algae development on lower roof surfaces

Given the number and/or extent of the individual defects described above, we feel the overall conditions indicate that the present roof covering has lost its integrity and no longer suitable for repairs. Replacement of the roof covering is, therefore, recommended and should include replacement of rotten wood substrate and/or related components, when found.

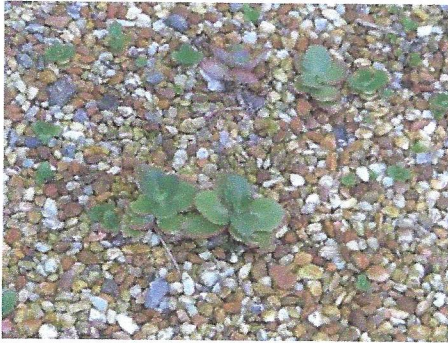
View of typical vegetation growth on the lower roof surfaces

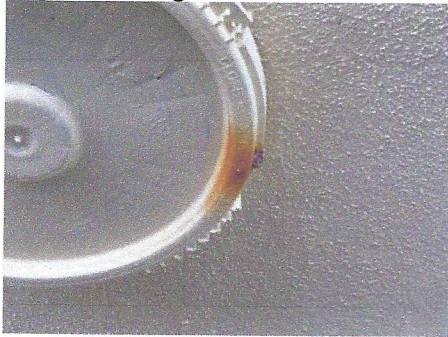
- The lower roof section exhibits evidence of leakage at numerous locations throughout the covered parking garage. The roofing system was installed in 2002, as previously noted above and therefore has exceeded its useful service life. The typical useful service life of built-up tar and gravel roofing systems is generally 12-16 years.

Closer view of leakage evidence through improvised light fixture cover

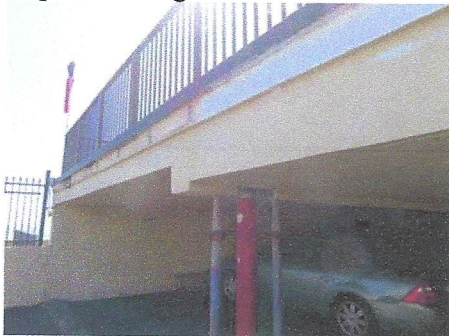
View of reemergence of leakage evidence along north edge after previous refinishing

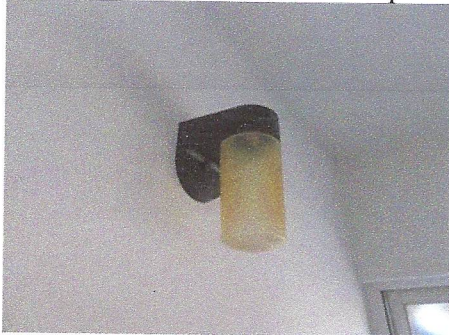
View of damaged light fixture in north stairway at fourth-floor landing

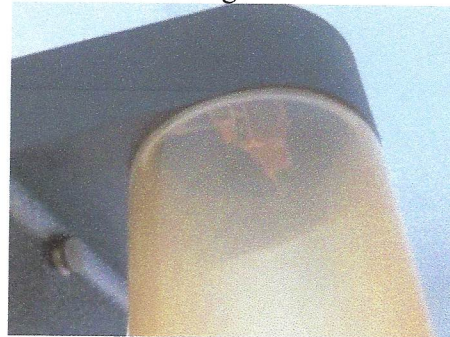
Closer view of damaged light fixture

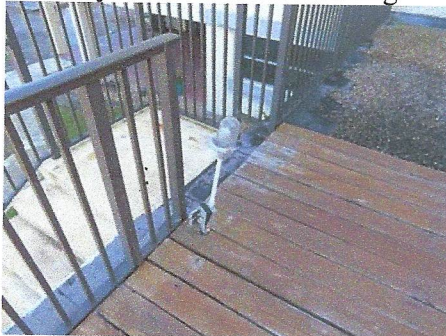
- There was disconnected conduit with exposed wiring at the front carport north side which needs to be repaired.
- The rear deck area stairway light fixture is damaged and needs to be replaced.

View of damaged light fixture at rear deck stairway

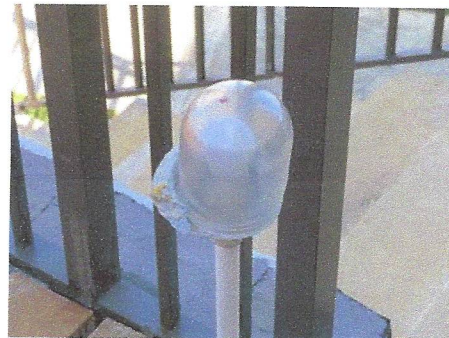
Closer view of damaged light fixture

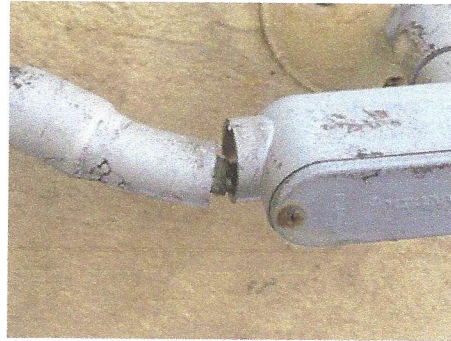
Closer view of disconnected conduit and exposed wiring

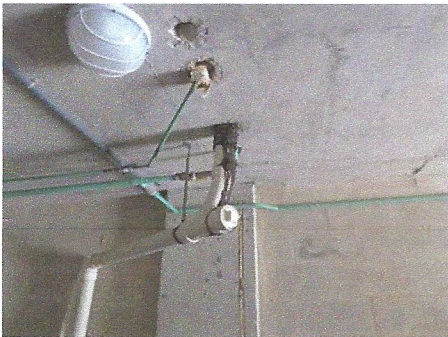
View of leakage evidence at PVC waste line connection to cast iron in pool equipment room

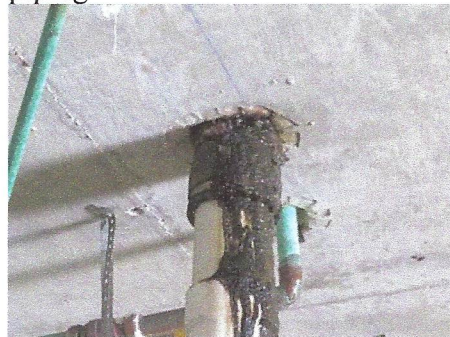
Closer view of leakage evidence

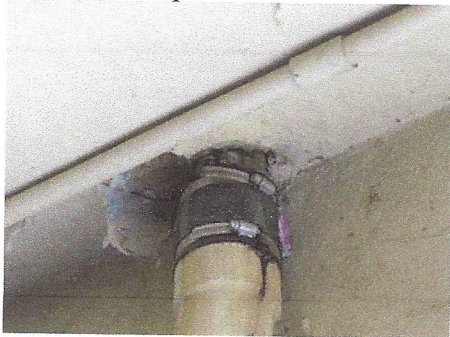
View of typical improper repair evidence and leakage waste piping

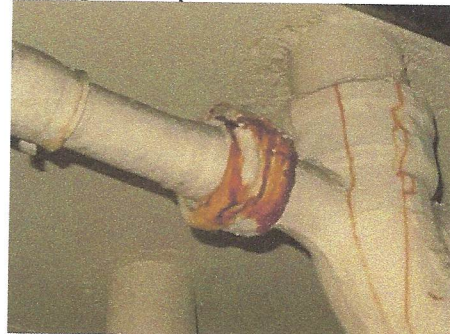
Closer view of leakage evidence from cast-iron waste piping

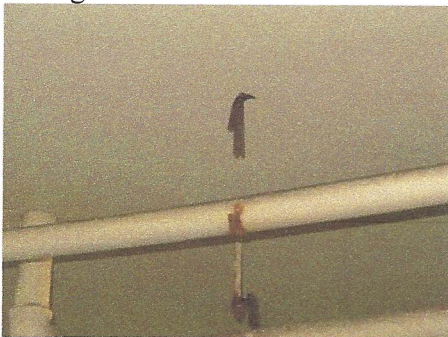
Closer view of piping supports which have rusted away in covered parking areas

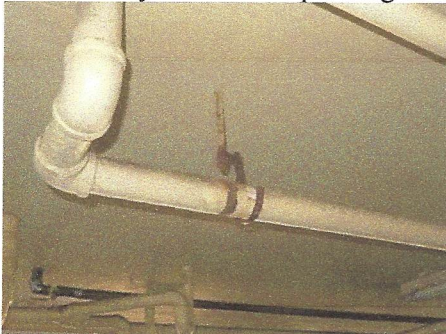
Another view of piping supports which have rusted away in covered parking areas

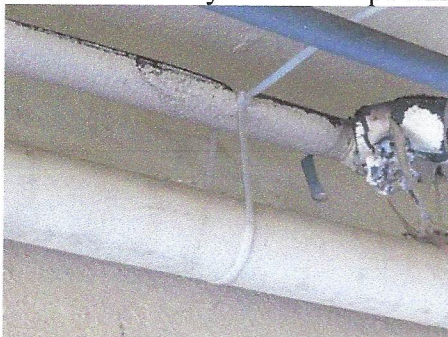
Closer view of improper piping support

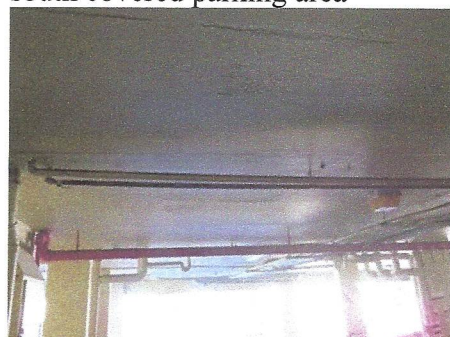
View of unsupported waste piping in north covered parking area

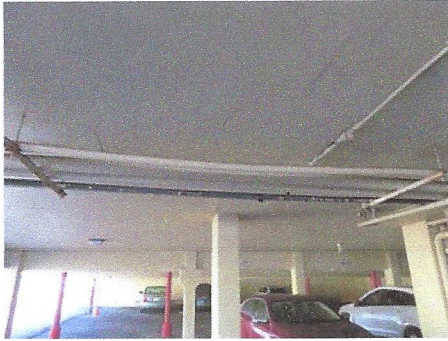
View of unsupported waste piping in north covered parking area

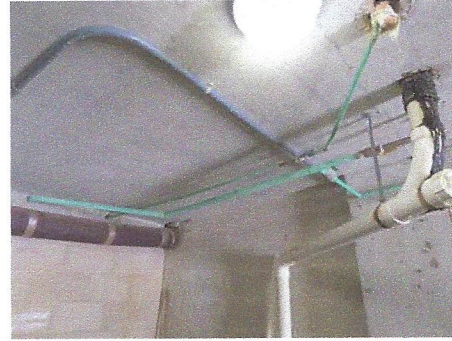
View of unsupported supply piping in pool equipment room

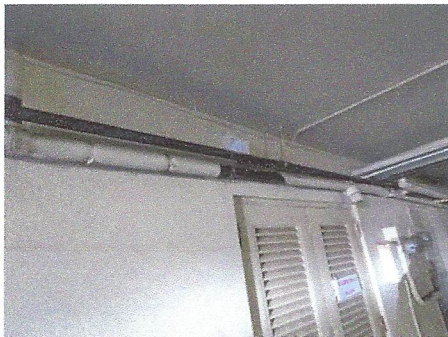
- The hydronic supply and return lines exhibit evidence of previous leakage and improper/temporary repairs at various locations throughout the covered parking areas. All areas exhibiting evidence of leakage and improper repair should be located and corrected. The hydronic piping is wrapped with insulation in most areas, which conceals possible defects. It is the recommendation of this firm that the insulation should be removed from a representative number of locations to ascertain the condition of the piping and whether additional deficiencies are present.

View of typical hydronic supply/return lines in covered parking areas

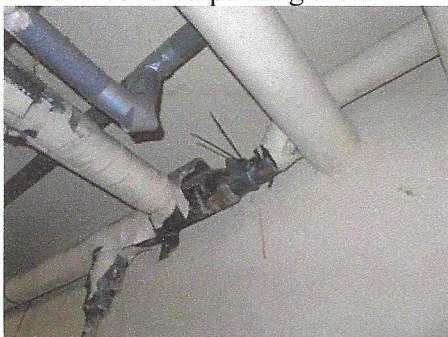
Another view of typical hydronic supply/return lines in covered parking areas

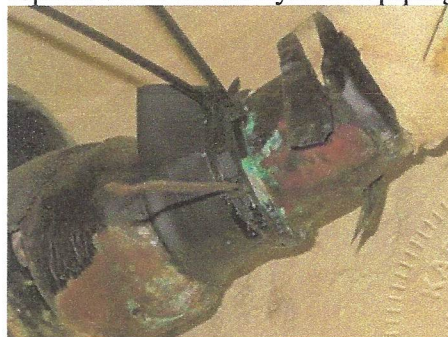
View of typical improper/temporary repairs observed on hydronic piping

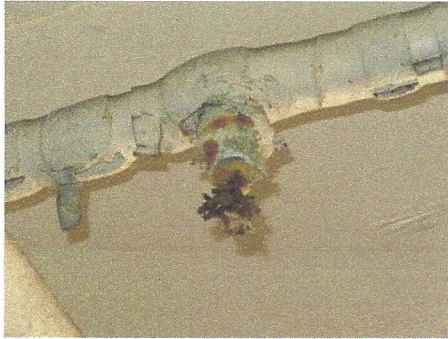
View of typical nonfunctional shut-off valve with deteriorated valve handle at hydronic piping in covered garage areas

- Most, if not all, of the shut-off valves at the hydronic supply/return lines throughout the covered parking areas have deteriorated valve handles and are inoperable. Replacement of the all affected shut-off valves is recommended.

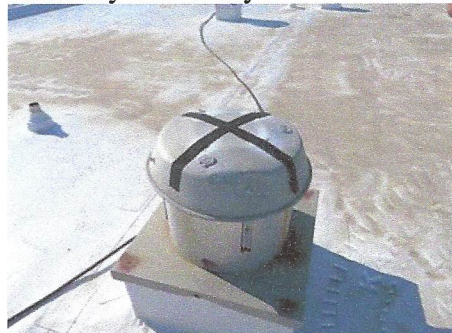
View of typical improper duct tape repairs at ventilation dome/covers

- Most, if not all, of the rooftop ventilation domes/covers have been improperly repaired and/or secured with duct tape or the like. There were also numerous areas with corroded or missing fasteners which permit moisture intrusion into the structure. The ventilation domes/covers should be properly secured in manner which provides protection against high velocity windstorms as well as moisture intrusion. If the ventilation domes/covers cannot be suitably repaired/secured, then replacement of the ventilation assembly is advised.

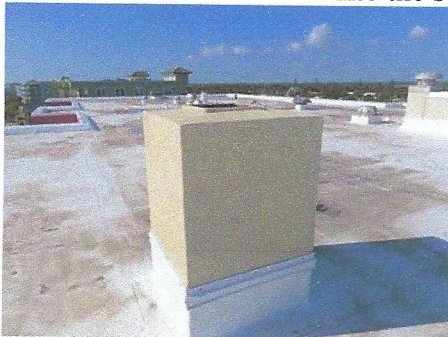
View of chimney at mid-east rooftop area which does not have a rain cap

- There rooftop mid-east exhaust flue (chimney) is open to weather and moisture intrusion. An appropriate cap should be installed to prevent moisture intrusion into the structure.

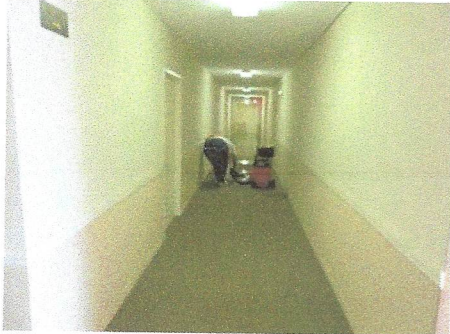
Notation: The evaluation of the mechanical systems within the confines of the individual living units was not part of this inspection, however leakage occurred from the supply lines at one of the unit air handlers during the time of this inspection, which resulted in inundation of the common areas and leakage into the lower floors.

View of inundation which occurred in fourth-floor south corridor due to leakage from air handler unit hydronic lines

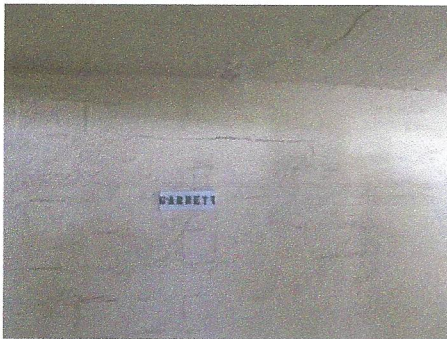
- Spalling conditions were visible at this structure in the following locations: south covered parking area ceiling/soffit over "Garrett" parking space, south covered parking area beam over southwest entry, south covered parking area ceiling/soffit over "Smith" parking space, south covered parking area south beam, north covered parking area ceiling and beam adjacent to #401, unit #505 balcony at corner, south covered parking area at the bottom of several columns, north and south covered parking area ceiling/deck at various plumbing penetrations, exterior north side column adjacent to barbecue area, exterior east side window sill north of card room and exterior north side headers/lintels over some of the second, third and fourth-floor windows. In addition to the above noted areas, there were numerous balconies with cracks at the corners and along the edges which should be sounded and/or opened to ascertain whether spalling is present.

View of spalling condition at ceiling in covered parking area near "Garrett" parking space

"Spalling" is a condition where the reinforcing steel rods within the concrete rust or scale, causing outward pressure upon the concrete and forcing the structural member to weaken at that point. We recommend the condition be repaired by breaking off any loose concrete, exposing the rebar to inspection, wire brushing the steel and/or replacing any steel that has lost 25% of its diameter and then using gunite or a high compression cement to replace the area of damaged concrete.

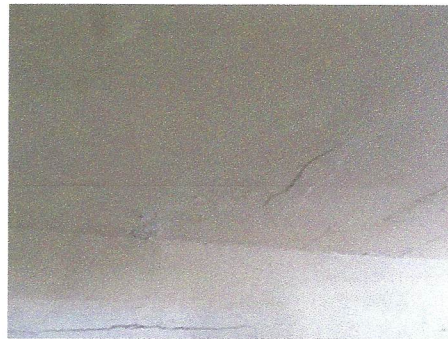
Closer view of spalling conditions

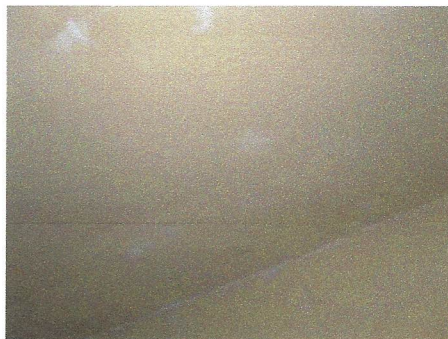
Closer view of spalling conditions

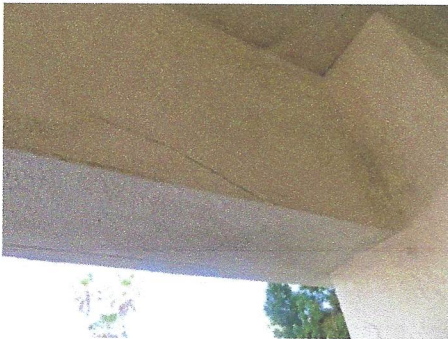
Another view of spalling conditions at beam

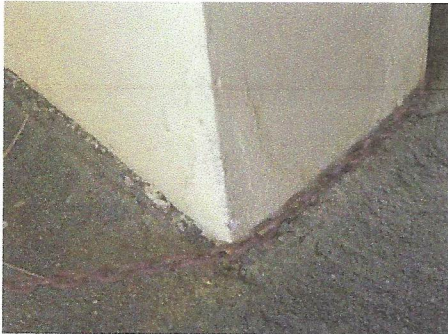
View of spalling conditions at base of column in south covered parking area

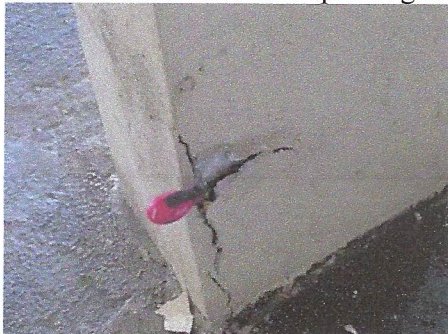
Closer view of spalling condition at base of column in south covered parking area

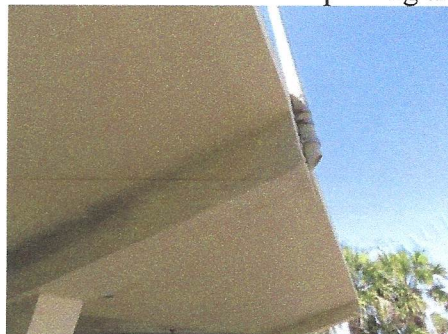
View of spalling evidence at north beam over front carport

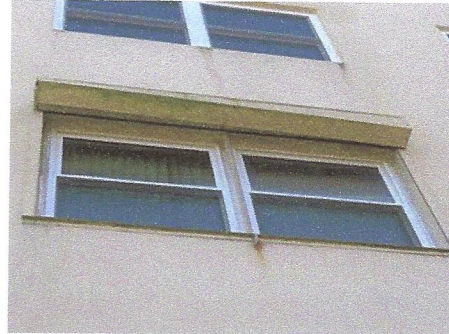
It is also noted that most, if not all, of the windows have roll-down storm shutters with externally mounted enclosures which may be concealing possible spalling conditions on the header/lintels. Additional evaluation beyond the scope of this visual inspection (i.e. removal of the shutter enclosures) may be necessary to ascertain the extent of spalling conditions.

View of typical exterior north side window with spalling condition at header/lintel

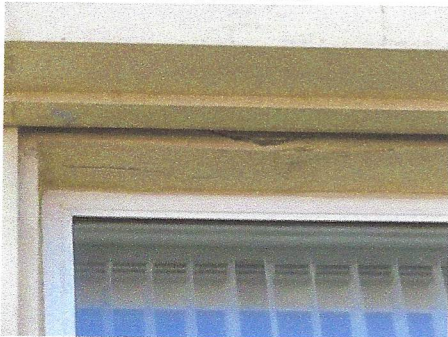
Closer view of spalling condition on header/lintel

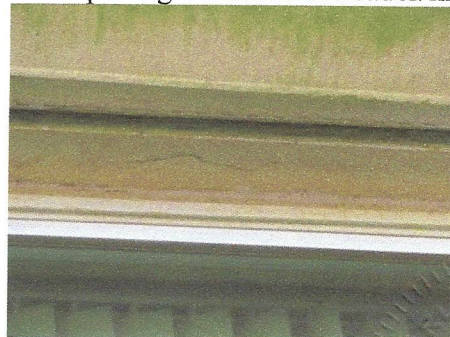
Another view of spalling condition on header/lintel

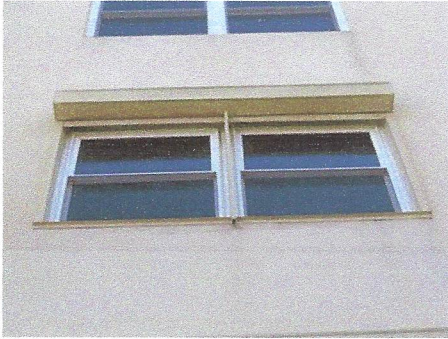
View of exterior north side window with spalling condition at sill below

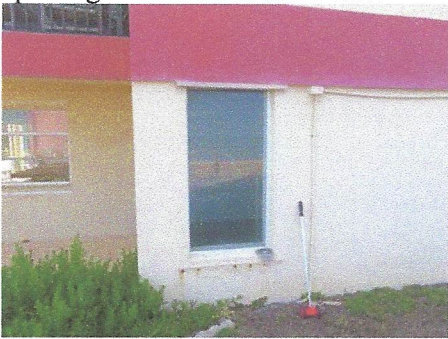
View of exterior east side window adjacent to card room with spalling condition at sill

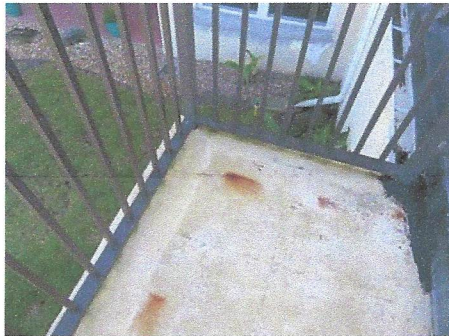
View of spalling condition at upper stairway landing

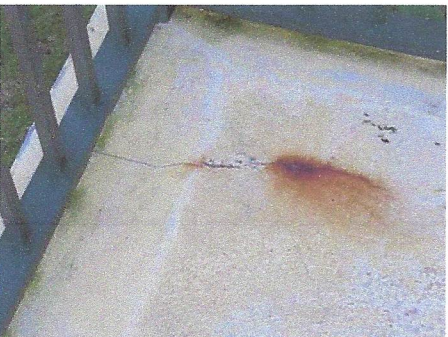
Closer view of spalling condition at landing

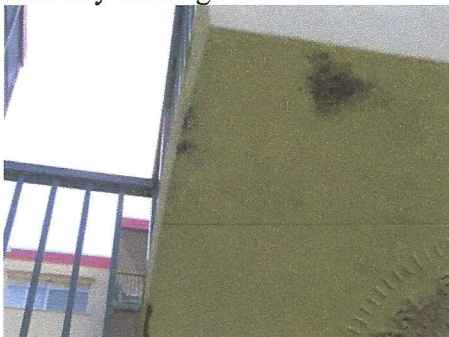
View of spalling condition at edge of landing

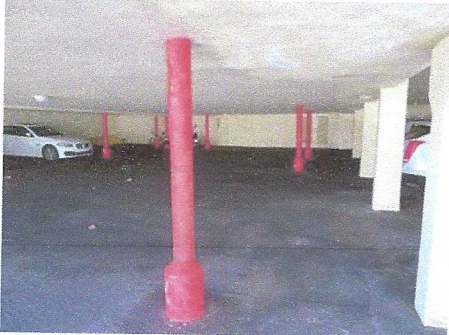
General view of typical north covered parking area columns

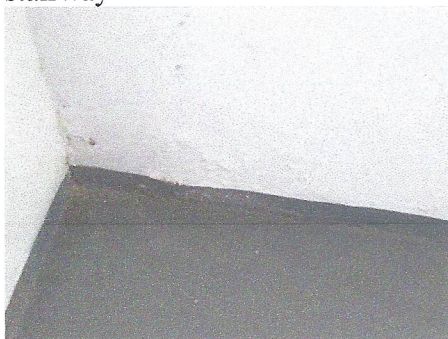
Closer view of moisture penetration evidence

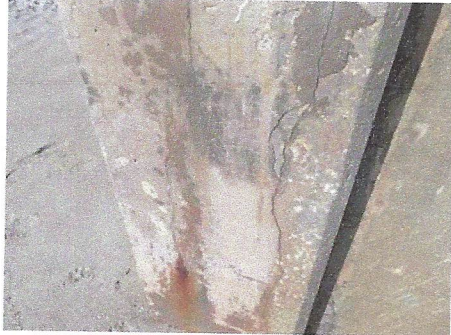
- Spalling conditions were observed at numerous locations of the retaining wall columns, cap and panels.

Closer view of typical spalling condition on seawall column

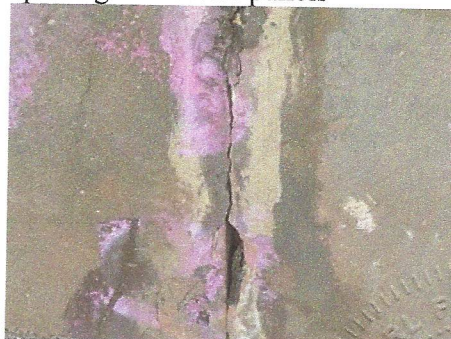
Closer view of typical open joint at seawall face

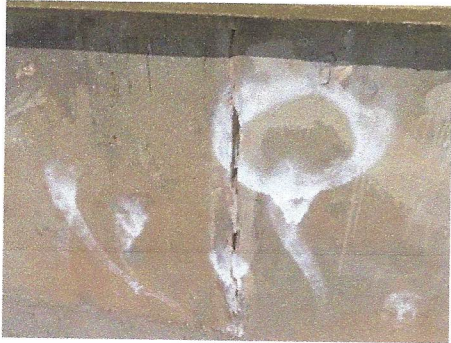
Closer view of typical open joint at seawall face

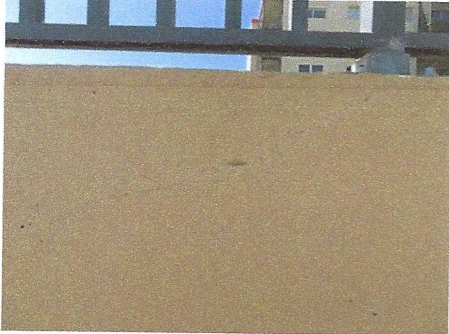
View of spalling evidence at seawall cap at east side

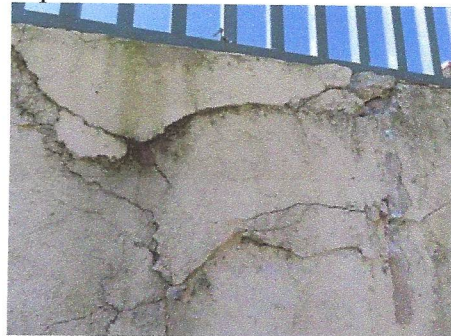
Closer view of spalling evidence at north side cap

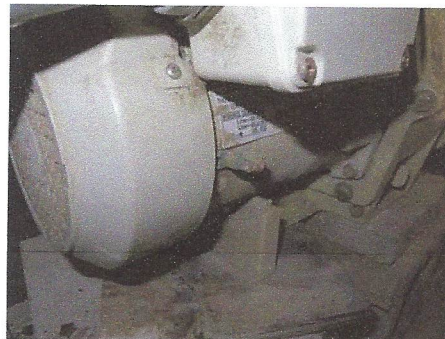
View of missing external bonding wire at pool pump motor

- The pool equipment external bonding protection is missing and needs to be installed for proper grounding of the system. An electrical contractor should be retained to properly ground the pool equipment with existing bonding for personal safety.

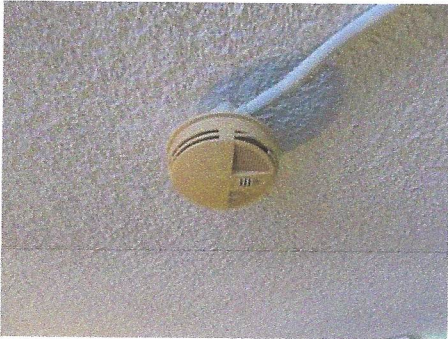
Given the number and/or extent of the individual defects described above, we feel the overall conditions indicate that the smoke detectors, fire alarm and fire communications systems are no longer suitable for repairs and therefore need to be replaced.

View of typical smoke detector device in hallway corridors which has exceeded its useful service life

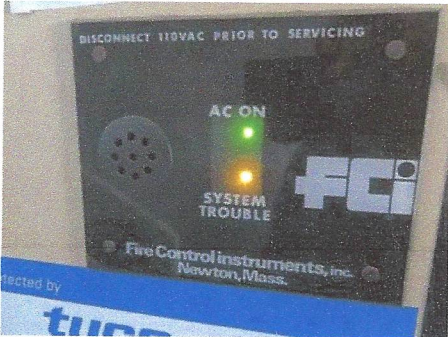
- There was a "System Trouble" code indicated on the fire alarm control panel indicating a fault within the system. The system is currently disabled and incapable of functioning as designed and intended.
- The Radionics Fire Alarm Communicator and Fire Control Instruments, Inc. Fire Alarm Control Center were manufactured in 1991 and therefore have exceeded their useful service life. Most fire alarm systems are manufactured to have a life span of 10 to 15 years. Of course, many systems are in service far longer, but maintenance and replacement parts become more costly and difficult to acquire once the manufacturer no longer supports the product.

View of "System Trouble" code displayed on fire alarm control panel
