Sandpiper Towers Condominium

Condition Survey Report Exterior Building and Balconies

Prepared By
James E. Emory, P.E.
Florida Registered Professional Engineer
Special Inspector #60965

November 11, 2019

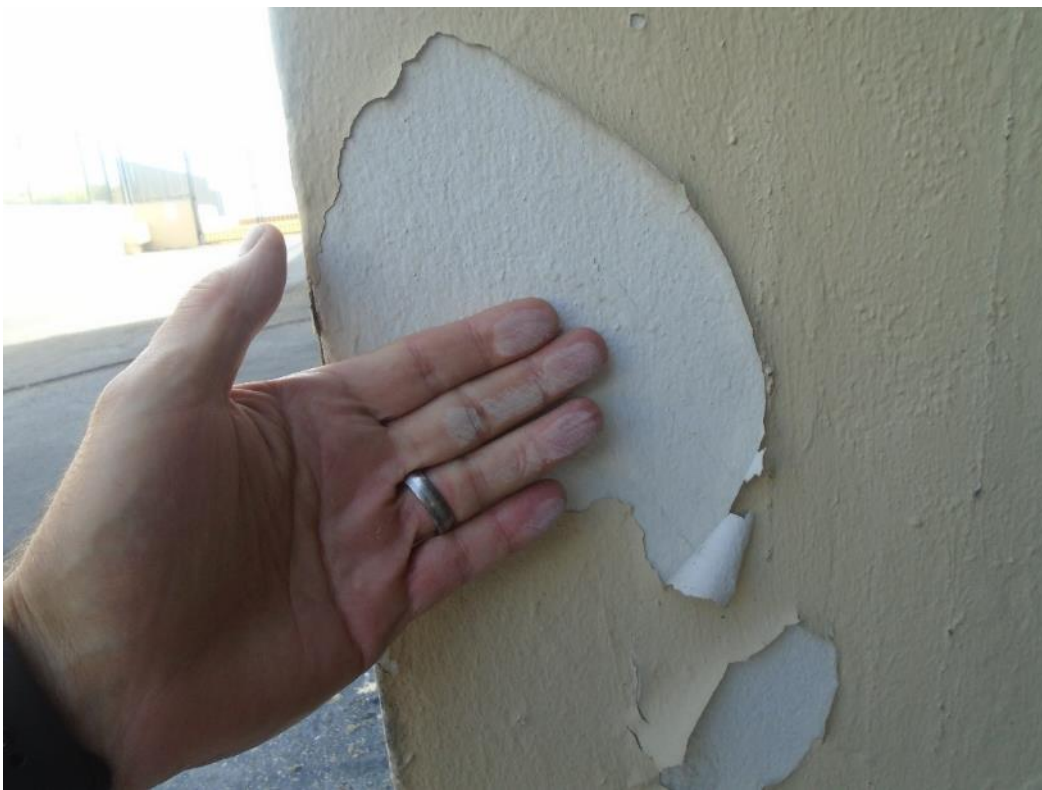
Example view of paint loss of adhesion-chalkiness under substrate-poor surface prep

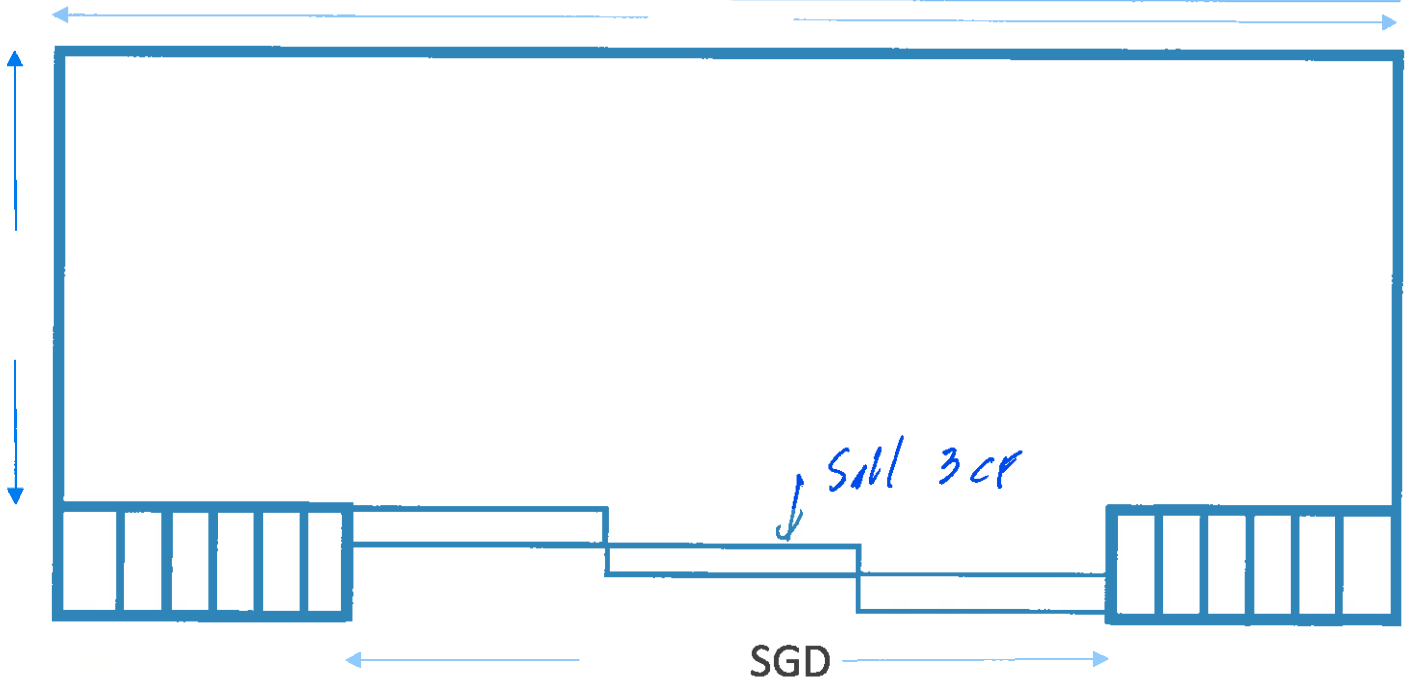
LEGEND Spall Above Spall Below Crack Rust Spot	Railings Code Compliant: Yes No Condition: Good Fair Poor Type: Cored Surface Mount Screen	Sliding Doors Code Compliant: Yes No Condition: Good Fair Poor Age: Older Newer Corroded Fasteners: Yes No Holes In Threshold: Yes No
	Shutters Yes No Edge Door Accordion Roll Down	Flooring Type: Coating
	Screened Enclosure Condition: Fair

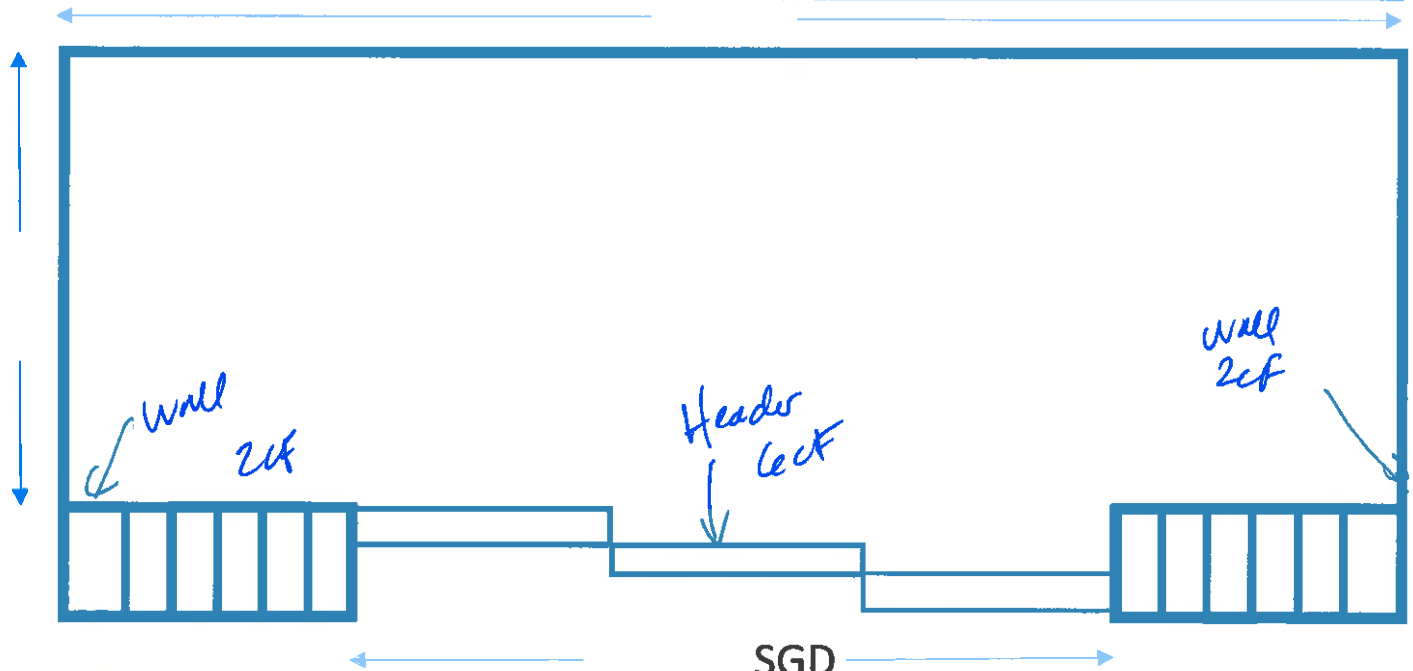
LEGEND Spall Above Spall Below Crack Rust Spot	Railings Code Compliant: Yes No Condition: Good Fair Poor Type: Cored Surface Mount Screen	Sliding Doors <i>Corr. Part</i> Code Compliant: Yes No Condition: Good Fair Poor Age: <u>Older</u> Newer Corroded Fasteners: Yes No Holes In Threshold: Yes No
	Shutters <u>Yes</u> No Edge <u>Door</u> Accordion <u>Roll Down</u>	Flooring Type: <i>Coating</i>
	Screened Enclosure Condition: <i>New</i>

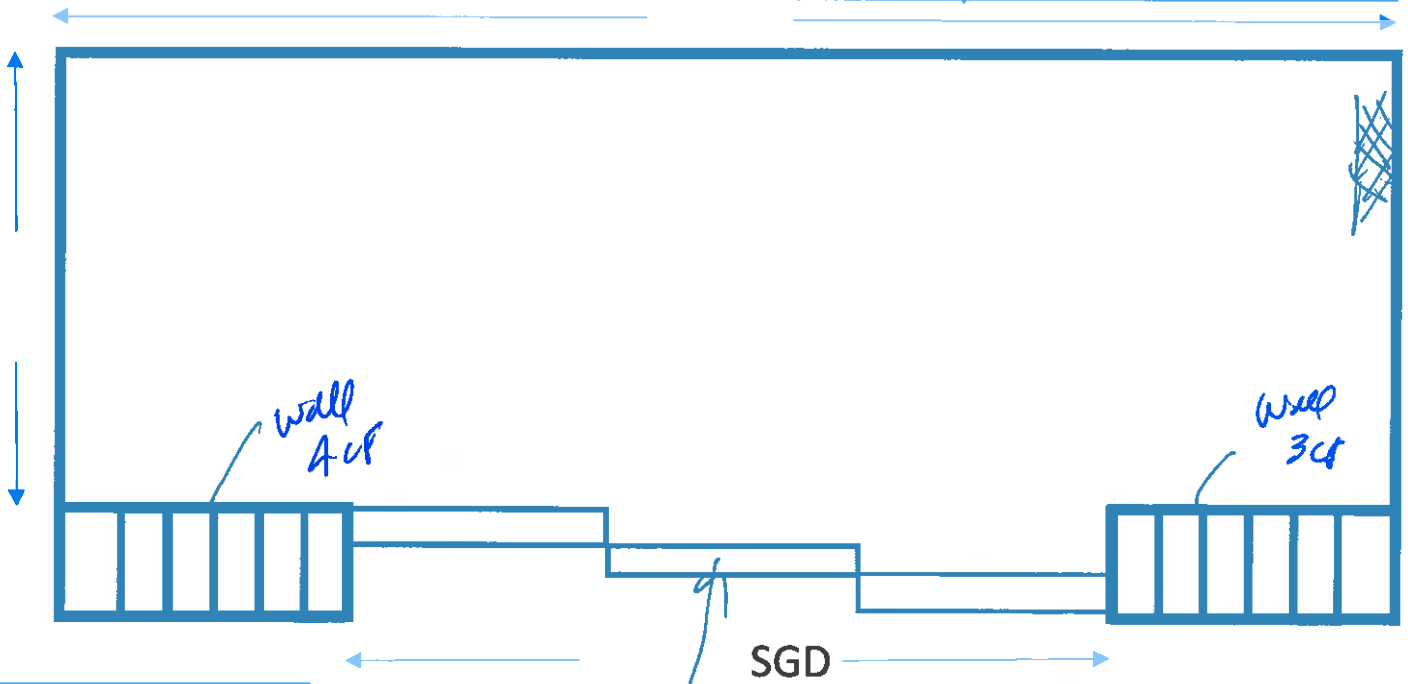
Rust Spot	Railings Code Compliant: Yes No Condition: Good Fair Poor Type: Cored Surface Mount Screen	Sliding Doors Code Compliant: Yes No Condition: Good Fair <u>Poor</u> Age: <u>Older</u> Newer Corroded Fasteners: Yes No Holes In Threshold: Yes No	
	Shutters <i>Car-Inst</i> <u>Yes</u> No Edge <u>Door</u> <u>Accordion</u> Roll Down	Flooring Type: <i>Cooking - tile pattern</i>	Screened Enclosure Condition: <i>fair</i>
