# BUILDING INSPECTION SERVICES

March 25 & 26, 2019

Sandpiper Towers Condominium Association, Inc.  
c/o Dennis Smith (President) & Dolores Melton (Treasurer)

205 Highway A1A  
Satellite Beach, Florida 32937

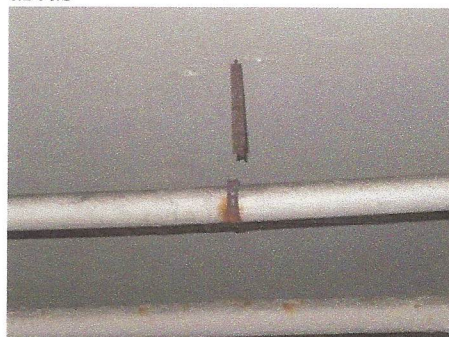
Closer view of piping supports which have rusted away in covered parking areas

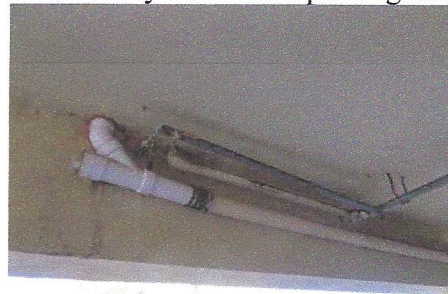
View of improper support of piping in south covered parking area

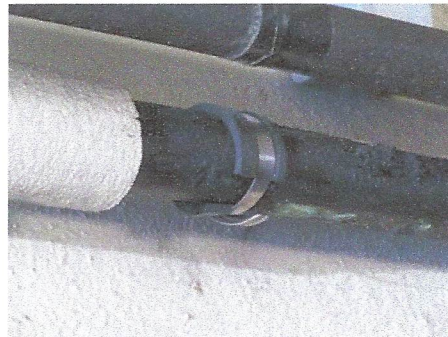
- The hydronic supply and return lines exhibit evidence of previous leakage and improper/temporary repairs at various locations throughout the covered parking areas. All areas exhibiting evidence of leakage and improper repair should be located and corrected. The hydronic piping is wrapped with insulation in most areas, which conceals possible defects. It is the recommendation of this firm that the insulation should be removed from a representative number of locations to ascertain the condition of the piping and whether additional deficiencies are present.

View of typical improper/temporary repairs observed on hydronic piping

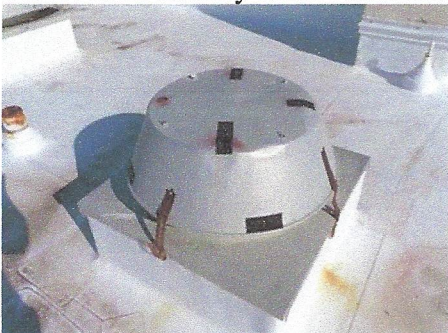
View of typical improper duct tape repairs at ventilation dome/covers

- Most, if not all, of the rooftop ventilation domes/covers have been improperly repaired and/or secured with duct tape or the like. There were also numerous areas with corroded or missing fasteners which permit moisture intrusion into the structure. The ventilation domes/covers should be properly secured in manner which provides protection against high velocity windstorms as well as moisture intrusion. If the ventilation domes/covers cannot be suitably repaired/secured, then replacement of the ventilation assembly is advised.

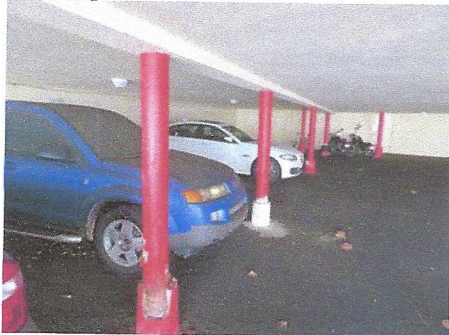
General view of typical north covered parking area columns
